Surface Hydrophobicity in Medium Voltage Terminations

K. Väkeväinen

Ensto Utility Networks, Ensto Finland Oy, Porvoo, Finland

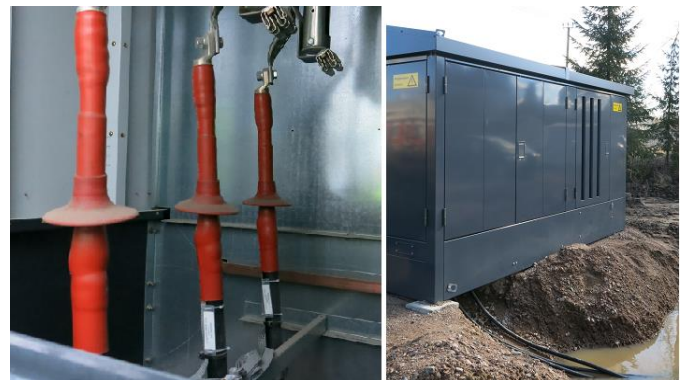
Figure 1. Typical installations sites with dust accumulating on the termination surfaces and water level close to the bottom of the secondary outdoor substation.

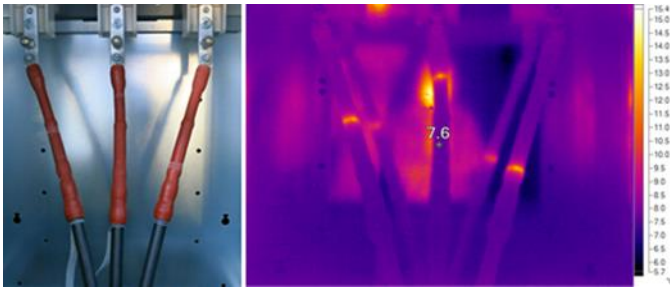
Surface discharges can occur on medium voltage terminations when sufficient amount of conducting particles and moisture accumulated on the insulating termination surface. The operating conditions inside of unheated outdoor enclosures have proved to be challenging for the terminations and insulators used inside of these structures. Typical substation installations are shown in Figure 1 with dust accumulation on the termination surface and water level close to the bottom of the enclosure. The problems with surface discharges can be hard to identify, since it can take years before the first signs of discharges are visible on the insulating surfaces. Several methods are available for detecting discharge occurrence on medium voltage terminations, but a visual inspection combined with thermal imaging offers an easy and effective way to identify discharge occurrence on termination surfaces. The main advantage of this method is that it can be done without outages in most substation models. The use of thermal imaging also gives good indication of discharge occurrence on termination or insulator surfaces before the actual discharge occurrence can be seen or heard. A thermal image of a heat shrink indoor termination with surface discharges is presented in Figure 2.

Figure 2. Identification of discharge occurrence on terminations by thermal imaging.

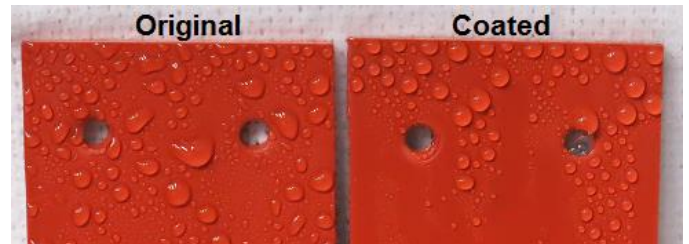
The hydrophobicity of the material used in the studied heat shrink indoor terminations was compared to the hydrophobicity classes given in the STRI guide. An original material sample and a silicone coated sample was studied and compared to the classes given in the STRI guide. Water droplets on heat shrink material samples are shown in Figure 4. The hydrophobicity of the original sample corresponds to HC 2 and the silicone coating improves its hydrophobicity to HC 1. A fast test like this can easily indicate that the surface hydrophobicity of the material can be improved simply by applying a silicone coating, but the performance difference for this improvement on real terminations had to be studied on field installations to see if this improved hydrophobicity would actually last when the terminations are subjected to the real environmental conditions inside of a secondary outdoor substations.

Figure 4. Hydrophobicity of original vs. coated surface.

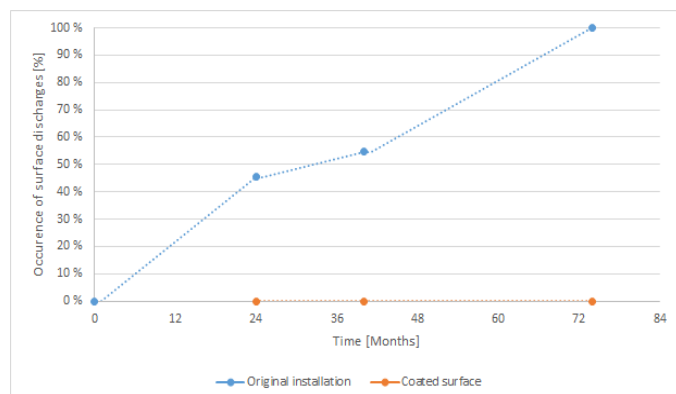
The first ten of the originally installed terminations had traces of surface discharges already after 24 months in operation. This corresponds to 45 % of all the installed three-core terminations at this site. It can be assumed that these ten terminations were installed in the substations with the worst environmental conditions, because all the inspected terminations are of the same type. At the time of the second inspection, two more of the originally installed terminations had traces of surface discharge occurrence on the surface. This means that more than 50 % of the originally installed terminations had been subjected to surface discharges after 40 months in operation. Surface discharge occurrence on this many terminations clearly indicate that the originally installed heat shrink indoor terminations are not the correct accessories to be used in these secondary outdoor substations at this site. The discharge occurrence on these terminations at different inspections are shown in Figure 5.

Figure 5. Occurrence of discharges versus termination age.
