Comparison of NDT methods to detect debonded interfaces

ABSTRACT: This paper compares different Non Destructives Techniques (NDT) to detect and characterize artificial debonding and internal crack created in an experimental pavement tested on the fatigue carrousel of IFSTTAR in Nantes. The tests presented are performed on a 25 m long pavement section, consisting of 2 bituminous layers (8 cm thick base layer, and 6 cm thick wearing course), over a granular subbase. Several types of defects have been included at the interface between the two asphalt layers. Rectangular debonded areas of different size (longitudinal or transversal direction) have been created artificially, using different techniques (sand, textile, absence of tack coat). The construction has been done by a road construction company, using standard road works equipment. Different NDT, as electromagnetic techniques (ground-penetrating radar, step-frequency radar) or as mechanical techniques, from static deflection (FWD) and radius of curvature (inclinometer) measurements to dynamic methods (Ultrasonic Pulse Echo, Frequency Response Function), have been used to detect the different geometrical characteristics of the art

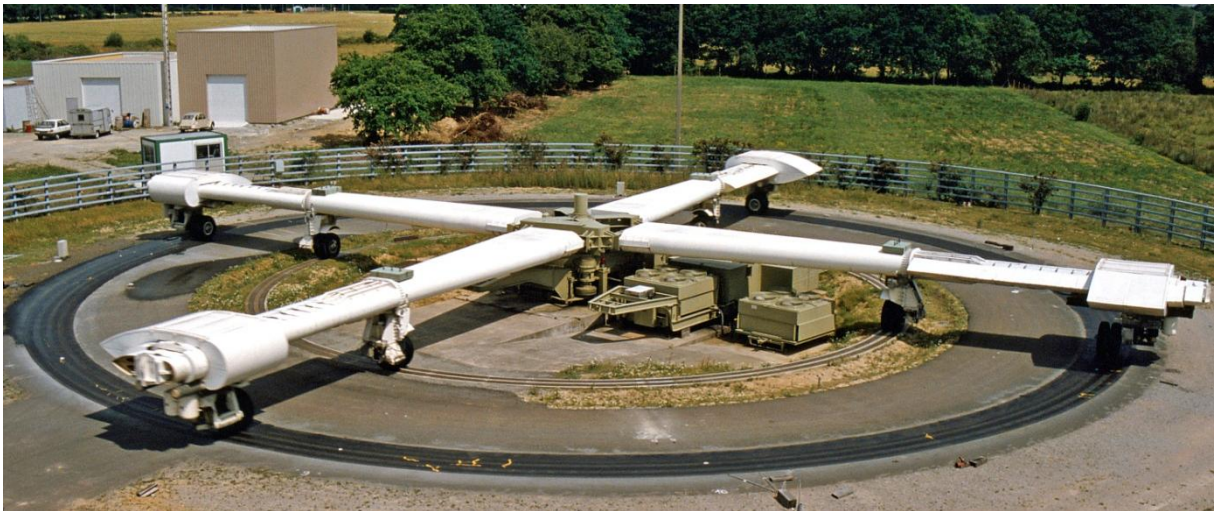
The test site is located on the pavement fatigue carousel of IFSTTAR (Figure 1). A full scale experiment investigating low traffic pavements started on the test track in March 2011. A first part concerned mainly the testing of pavements with geogrid reinforcement and consisted in loading the outer radius (19 m) during 1.2 million load cycles (Hornych 2012). The second part started in the spring of 2012, and consisted in loading the inner radius (16 m), where the section with defects is located. This test section is 25 m long and consists of two bituminous layers (8 cm thick base layer, and 6 cm thick wearing course), over a granular subbase (30 cm thick). Several types of defects were intentionally incorporated into the base layer or at the interface between the two asphalt layers.

Figure 1. The pavement fatigue carousel of IFSTTAR

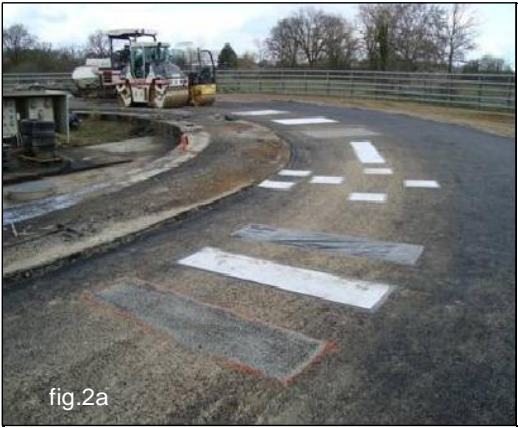
The construction of the pavements was carried out by a road construction company, using standard equipment. Rectangular debonded areas were incorporated at the interface between the two bituminous layers. Table 2 presents their dimensions and the technique used: sand, textile, or absence of tack coat. Figure 2 presents a photograph of the debonded areas before the wearing course construction (2a) and a map of the experimental section, with the location of the different defects (2b).

These defects were centered on the radius $R = 16$ m, which corresponds to the centre of the wheel-path. The total width of the wheel-path (with lateral wandering) was approximately 1.0 m (between 15.5 m and 16.5 m). The debonded areas I-1, I-2, I-3, I10, I11 I12 and I13 are centered on the radius of 16 m. I-4 to I-9 are small defects, 50 x 50 cm, with a textile interface, located in and outside the wheel path.

Figure 2. 2a: Interface defects before wearing course construction 2b: Map of the different debonded areas

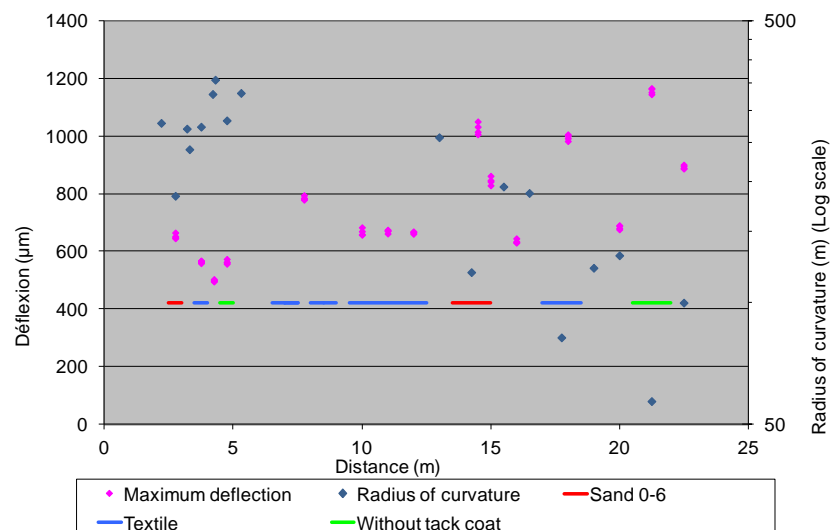
Figure 3. Maximum deflection measured with an FWD and radius of curvature measured with an inclinometer along the test section

Figure 3 locates the debonded areas and their type and presents along the profile:

- Maximum FWD deflections at the highest load level normalized at 75 kN;
- Radius of curvature (in logarithmic scale).

Deflections varied from 495µm to 1165µm depending on the measurement point. High deflection values were clearly obtained above or close to the largest debonded areas (I11, I12, and I13). Small debonded areas were much more difficult to detect, with deflection values close to those obtained on areas without defects, except perhaps for the measurement point located between the small defects I-4 to I-9. It is also difficult to precisely locate the position of the defect, and to make a clear difference between the different defect types using only the maximum deflection. Radius of curvature varied from 57m to 360m. Variation of radius of curvature measurement level was also observed above or close to the largest debonded areas (I11, I12, and I13).

FWD tests and inclinometer measurement were performed along a longitudinal profile at the 16 m radius, on the pavement section with defects before loading the test section. Four FWD load levels were applied and the test was repeated four times at each level. The radius of

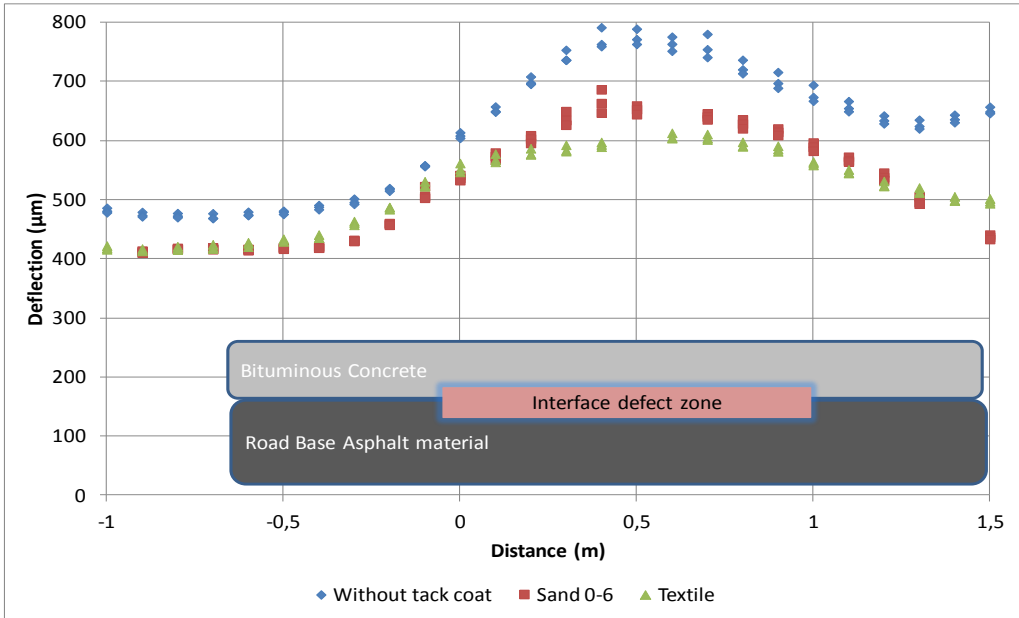
Figure 4. Maximum deflections measured with the HWD (80kN load) above the 3 types of defects

Interface defects affect measurements of maximum deflection and radius of curvature. However, in these first measurements, the sampling distance between two consecutive measurements was too large to locate accurately the extension of the defects. We used the opportunity of the presence of the HWD from the Civil Aviation Technical Centre in Nantes to renew the tests with an appropriate sampling rate. HWD load was reduced to 80kN, and 3 measurements were performed every 10 cm above the larger defects (I11, I12 and I13). Figure 4 presents the maximum deflections measured at the center of the loading plate, above the different types of defects. Deflection level clearly increases when the HWD is above the defect. It starts to increase when the sensor is 0.30 m before the limit of the defect. At this point, the edge of the 450 mm diameter plate is above the defect. Then, deflection increases up to a maximum level which corresponds to about 150 % of the initial level (160% in the case of sand or interface without tack coat and 140% in the case of textile). Deflection then decreases up to the initial level, except at the end of the interface without tack coat. This last

case corresponds to the end of the test section and presents thickness variations due to the construction of this transition zone. Similar curves can be drawn with deflections measured by sensors 2 and 3 located at 300 and 400 mm from the center of the plate. However, the maximum increase is less important than for the sensor located at the center of the plate (135% for sensor 2 and 125% for sensor 3).

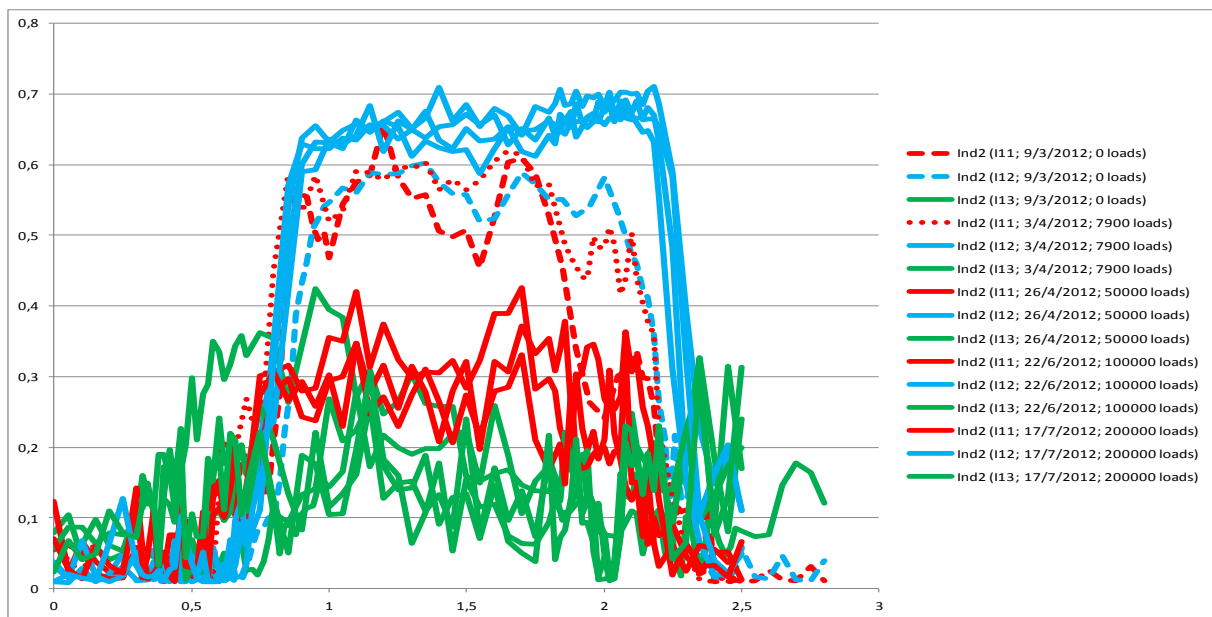
Figure 6. Evolutions of damage index from Colibri measurements, calculated in the frequency range 500-5000 Hz

Measurement results show that the Colibri and UPE methods are able to detect and locate the debonded areas and to make a distinction between them. Moreover the UPE device may also estimate the depth of the defect (from the propagation time), if material properties are known accurately. Shear wave velocity can also be used to determine material moduli (at the frequency of 55 kHz), which can give an indication of material damage. Measurement values from Colibri can be averaged within a frequency range to obtain a damage index, which can be practically used by pavement engineers. Figure 6 presents such damage index values calculated in the frequency range 500-5000 Hz for the 3 defects, from measurements made at

different dates and numbers of loads. Red (resp. blue and green) lines correspond to the investigation of the sand interface I1 (resp. textile interface I12 and interface without tack coat I13). An evolution of these damage indexes can be observed at the beginning of the experiment. Indexes corresponding to the textile interface increase slightly with the number of loads; while indexes corresponding to the sand zone decrease from 0.6 to 0.3. This decrease can probably be explained by a post compaction of the sand under loading. After 50 000 loads, and up to 200 000 loads, no further evolution of the damage index is observed either in the level of the index or the spatial limits of the defect.
