Frost heave in highway tunnels in Nordland County, Norway

P.O. Aursand

Norwegian Public Roads Administration, Bodø, Norway

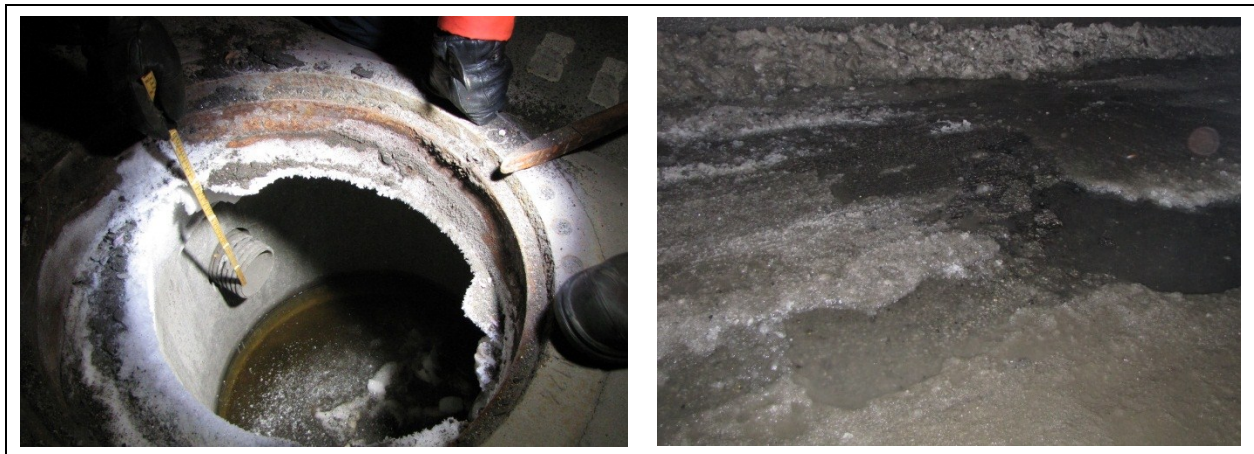
The 3,7 km long Umskardet tunnel is situated on the main road Ev12 east of the city of Mo i Rana near the border to Sweden at about 650 meters above sea level. It was opened in 2006. This tunnel has also suffered from frost heave and lumps of ice. The formation of ice lumps has been even more severe than in Korgfjellet tunnel. Several accidents with personal and material damage have occurred due to this. Figure 2 shows a shallow and frozen drainage well and ice lump formation on the road surface in Umskardet tunnel.

Figure 2: Shallow and frozen drainage well (left) and ice lump formation (right)

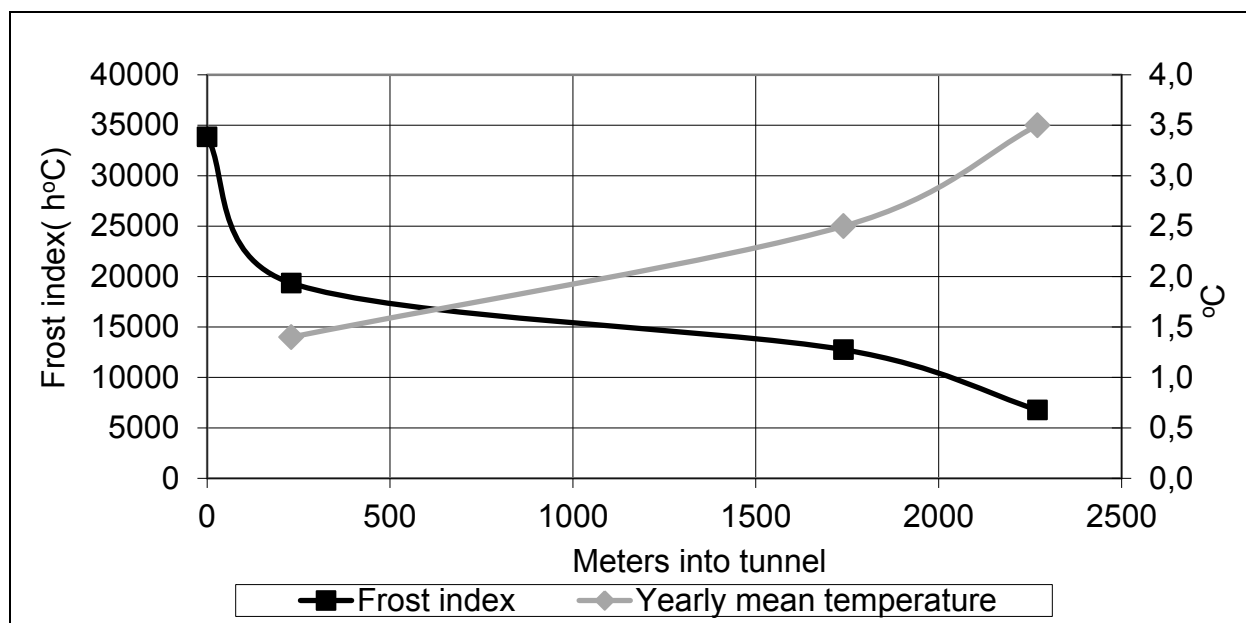
Korgfjellet tunnel was equipped with temperature sensors as shown in table 3. Figure 4 shows the measured frost index profile for Korgfjellet tunnel. The measured frost indexes correspond to about 115% of F_{10} (Frost index with 10 years return period). F_{10} is also the ruling for frost protection of tunnels in Norway, so the measured winter was well suited for assessing the tunnels performance against design. It can be seen in figure 4 that the frost penetrates at least in to 2500 meters. The frost index outside the tunnel was about 35000 $h^{\circ}C$, but at 230 meters into the tunnel the frost index decreased to about 20 000 $h^{\circ}C$, so it is clear that the heat from the bedrock lowers the frost index rapidly when moving into the tunnel. From 230 meters to 2270 meters the frost index does not decrease as much as might be assumed from the first 230 meters. At 1740 meters it is still about 13000 $h^{\circ}C$. This might have to do with the forced ventilation, and the fact that frost protection of the tunnel arch prevents heat flow from the bedrock. The measurements show that an assumption of frost zones of 300-500 meters was way too low and this design error was an important contributing factor to the problems.

Figure 4: Measured frost index in Korgfjellet tunnel march 2010 – march 2011

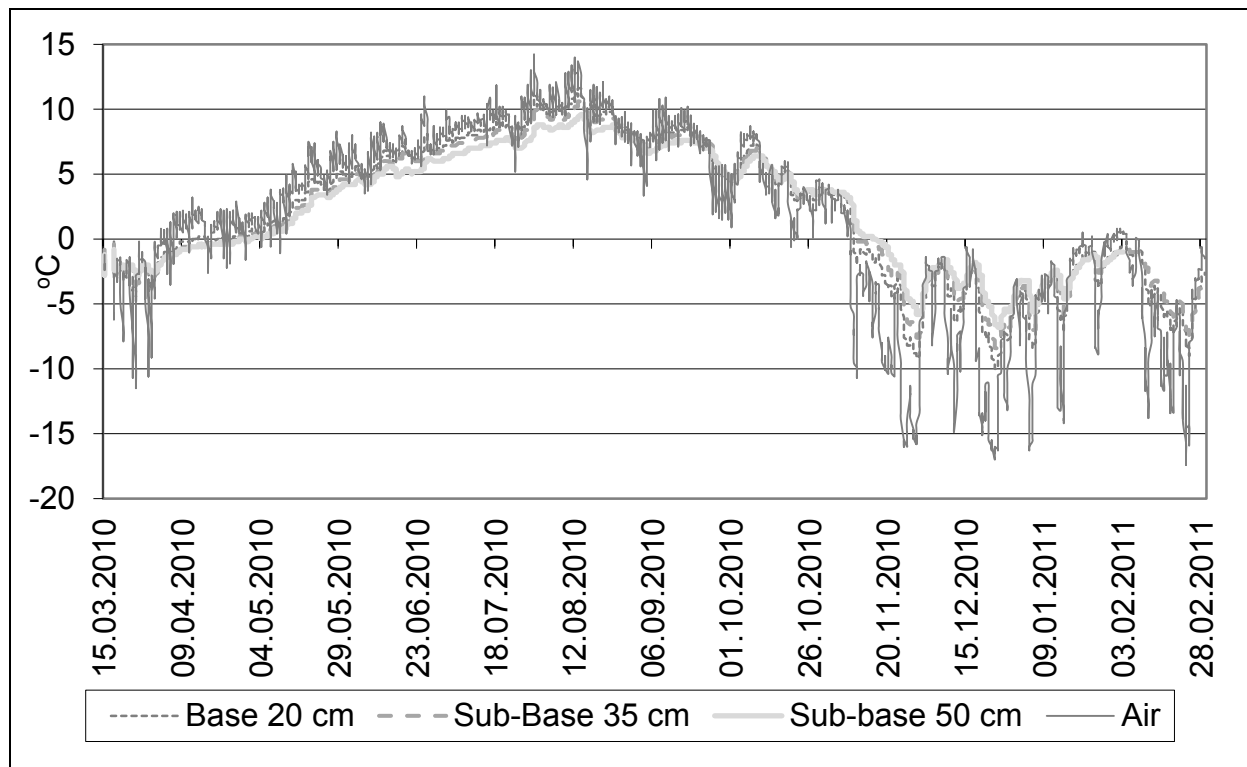
Real time measurements from all channels at meter 230 in Korgfjellet tunnel is shown in figure 5. The sub-base started to freeze around mid-November and didn't thaw until the beginning of May. Even though the air temperature in the tunnel drops below $-15^{\circ}C$, the

temperature in the sub base at 50 cm depth hardly drops below -6°C . The temperature in the sub base responds to changes in air temperature, but the fluctuations are smaller and delayed compared to the air temperature. The frost index at 50 cm depth was about $7400\text{ h}^{\circ}\text{C}$. This shows that the frost susceptible sub-base was subjected to high frost indexes, but the temperature was not very low making it possible for unfrozen water to be present forming ice lenses.

Figure 5: Measured temperatures at meter 230 in Korgfjellet tunnel march 2010 – march 2011.

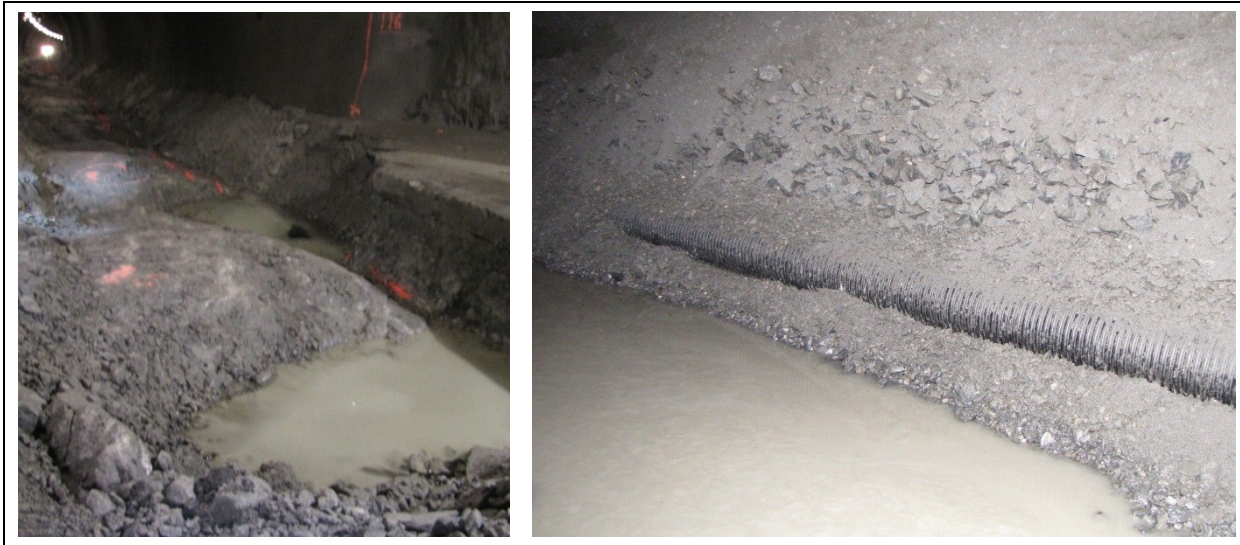
surface building hazardous lumps of ice. In addition to this, the pipes were not placed on the real formation rock-bed bottom but on the design formation rock-bed. Because of the blasting technique, depressions form every 5 meter in the formation rock-bed. These depressions where not drained because the pipe was placed too shallow, and a water table could form feeding the freezing front with water leading to severe frost heave. Figure 6 shows the depressions and a shallow drainage pipe in Umskardet tunnel.

Figure 6: Undrained depressions in the rock-formation bed and shallow drainage pipe.
