Case study on the rehabilitation of old railway lines: experimental field works

E. Fortunato; S. Fontul & A. Paixão

Laboratório Nacional de Engenharia Civil, Lisbon, Portugal

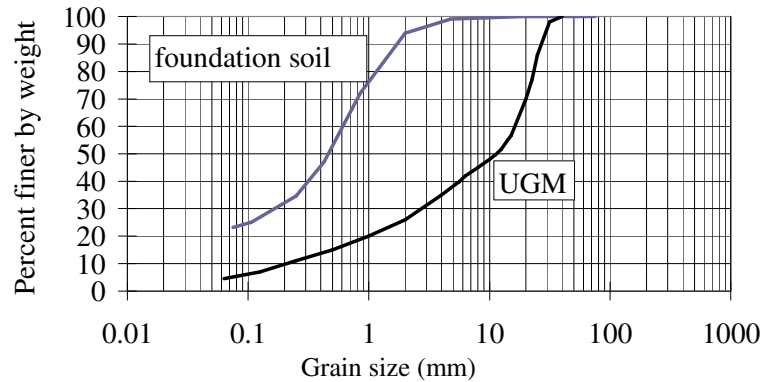
Figure 1: Grain size distribution of foundation soil and of UGM for reinforcement layer.

The selected ballasted track section to develop the studies is about 36 m long, with Iberian gauge (1.668 m) and with bi-block sleepers laid on a layer of limestone ballast. The soil of the foundation is sandy clay (Fig. 1) with plasticity index of 10. Despite being a granular soil, because of their intrinsic characteristics, namely a relatively high percentage of fine particles ($\%_{<#200}=23.2\%$), this soil may change substantially its consistency as a result of slight variations in water content, particularly when its water content is close to the optimum water content. The CBR value of the material is 9%.

The granite UGM of the reinforcement layer, which grain size distribution is shown in Fig. 1, has high resistance to fragmentation (Los Angeles value <26%) and high resistance to abrasion (Micro-Deval value <10%). This material was characterized through laboratorial cyclic load triaxial tests, applying several stress paths on large samples with different state conditions (Fortunato et al., 2012). The resilient modulus (E) of this material depends on the state conditions, particularly the water content (w -wopm) and the degree of compaction (D_c). Moreover, the modulus increases with the increase of mean stress. This behaviour was more evident in specimens with higher E , considering the same stress level and different state conditions (Fig. 5a). During construction of the experimental sections, the material was moistened to increase its water content to the optimum water content value (about 5.0%).

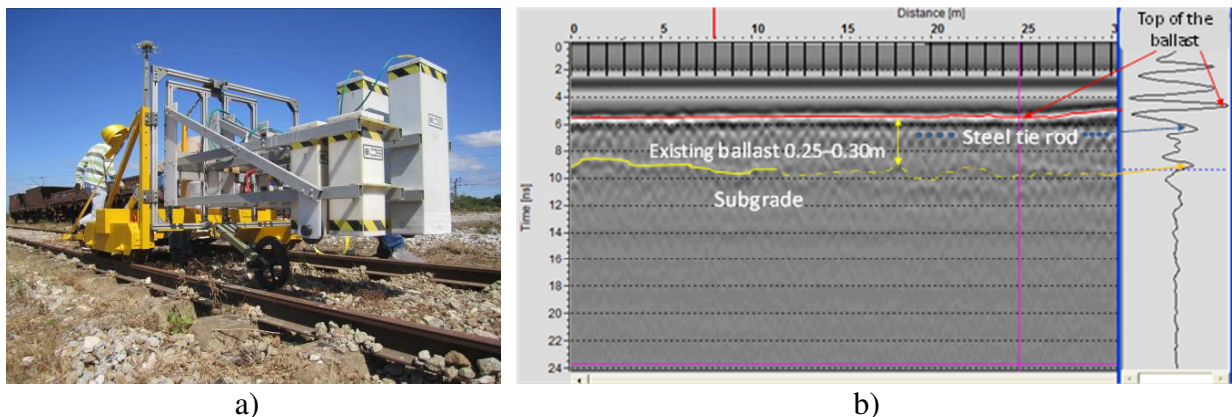
Figure 2: Tests with GPR before removing the old track: a) test equipment; b) results.

Two pairs of air-coupled (horn) antennas (1 GHz and 2 GHz) were used, with a maximum penetration depth of 0.80 m and 0.40 m, respectively (Fig. 2a). The calibration of the device was made in laboratory by determining the dielectric constants of the materials (Fontul et al., 2011) and by performing *in situ* test pits.

The results obtained with the GPR (Fig. 2b) allowed the identification of the interface between the ballast layer and the subgrade. The ballast layer ranged from 0.25 m to 0.30 m thick. The test pits showed a fouled ballast bottom layer.

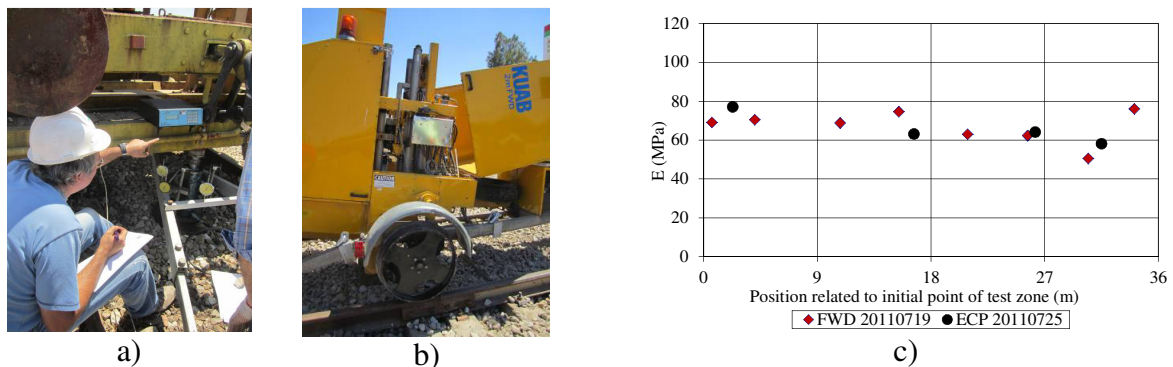
Figure 3: Load tests before removing the track: a) PLT; b) FWD; c) deformation modulus (E).

Before removing the superstructure of the track, PLT tests were performed on the ballast layer between sleepers, according to the procedure recommended by the standard NF P 94-117-1, yet using a 0.45m diameter plate (Fig. 3a). FWD tests (Fig. 3b) were also performed in order to try to relate the values obtained by this method with those obtained with PLT.

Two different load tests were performed: the PLT, applying a quasi-static pressure of 200 kPa on a 0.45 m load plate, and the FWD, applying a dynamic pressure of 500 kPa on a 0.40 m plate. Despite these differences, the deformation modulus values on the ballast layer at each test site were similar using both methods (Fig. 3c). In general, the modulus values ranged along the stretch between about 60 MPa and 80 MPa.

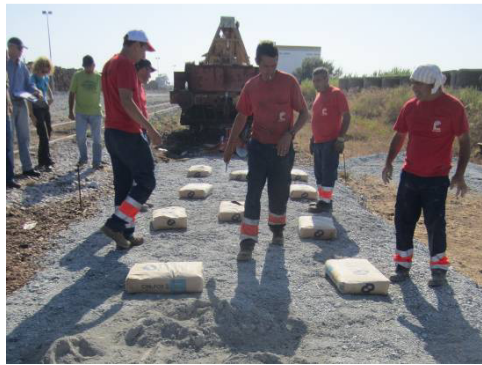
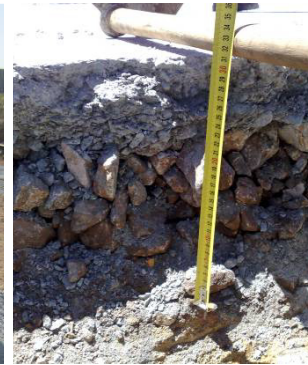
d) Section 1

Section 1 (9 m long)

- 10 cm of CBGM (5% of cement)
- 25 cm of Fouled Ballast (FB)
- Subgrade (SG)

Figure 4: Aspects of the experimental sections and pits after construction.

After the previously described tests, rails and sleepers were removed and the existing ballast was levelled and compacted. The test zone was divided in four sections with 9 m long each, in order to build different structural solutions on top of old ballast, creating a new platform, as presented in Fig. 4. In Section 4 only the ballast was levelled and no other layer was built on.

In Section 1, a 0.10 m well graded crushed unbound granular material (UGM) layer was spread over the existing old ballast; this UGM was mixed with cement (5%) and then the layer was compacted (CBGM); in Section 2 a 0.10 m UGM layer was spread on the existing ballast and mixed with it at the surface (UGM+B); after the compaction of this layer, a 0.20 m thick UGM layer was spread and compacted; in Section 3 a 0.10 m UGM layer was spread on the existing ballast and mixed with it at the surface (UGM+B); after the mixing process the layer was compacted; in Section 4 only the compaction of the existing ballast was done.

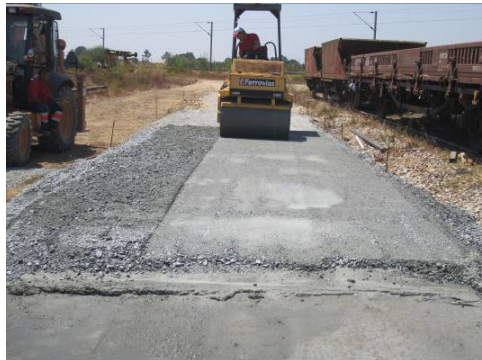
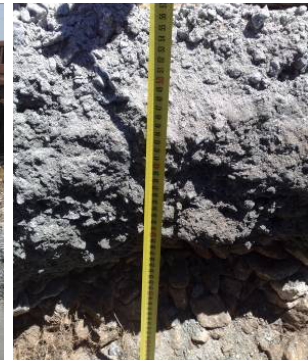
b) Section 2

Section 2 (9 m long)

- 20 cm of UGM
- 10 cm of UGM mixed with ballast (UGM+B)
- 25 cm of fouled ballast (FB)
- Subgrade (SG)

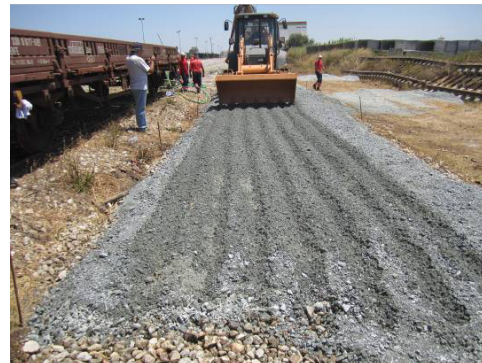
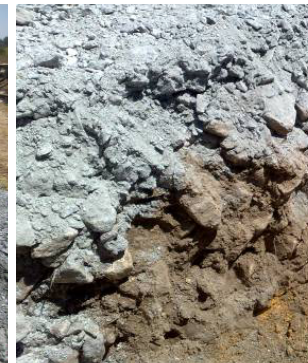
c) Section 3

Section 3 (9 m long)

- 10 cm of UGM mixed with ballast (UGM+B)
- 25 cm of fouled ballast (FB)
- Subgrade (SG)

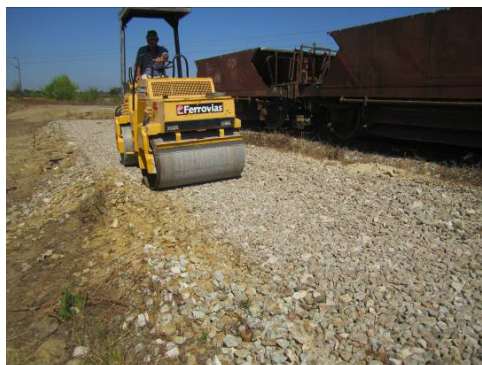
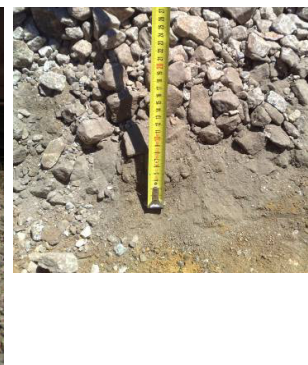
d) Section 4

Section 4 (9 m long)

- 25 cm of fouled ballast (FB)
- Subgrade (SG)

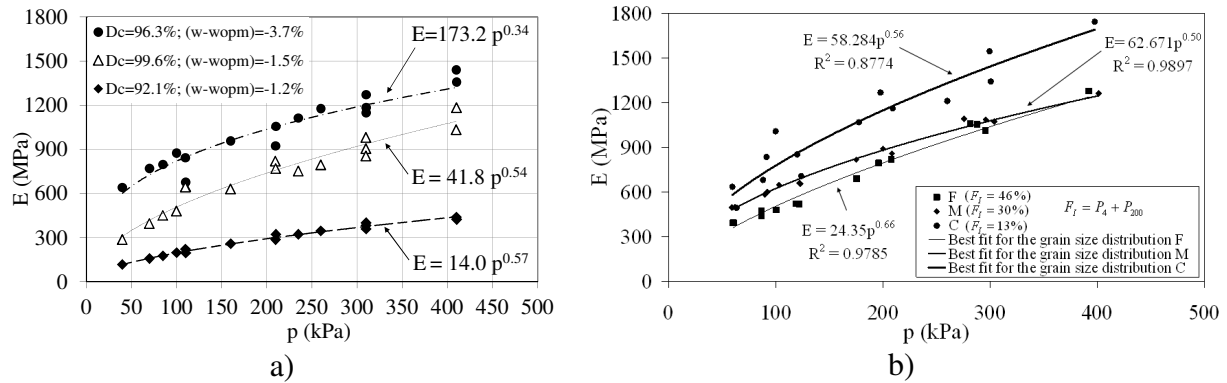
Figure 5: Resilient modulus obtained in cyclic triaxial load tests: a) UGM (Fortunato et al., 2012); b) Fouled Ballast (Fortunato et al., 2010).

On this track, the old ballast was essentially a limestone material. At the bottom of the layer, the ballast was fouled with fine particles from degradation of the ballast. This type of materials has been studied in recent years during railway renewal projects (Fortunato et al., 2010; Trinh et al., 2012). In particular, it was characterized by cyclic load triaxial tests performed on large specimens, using the full grain-size distribution. The resilient modulus depends on several parameters (Fig. 5b), including the fouling index, the degree of compaction and the stress level. The fouling index can be calculated by:

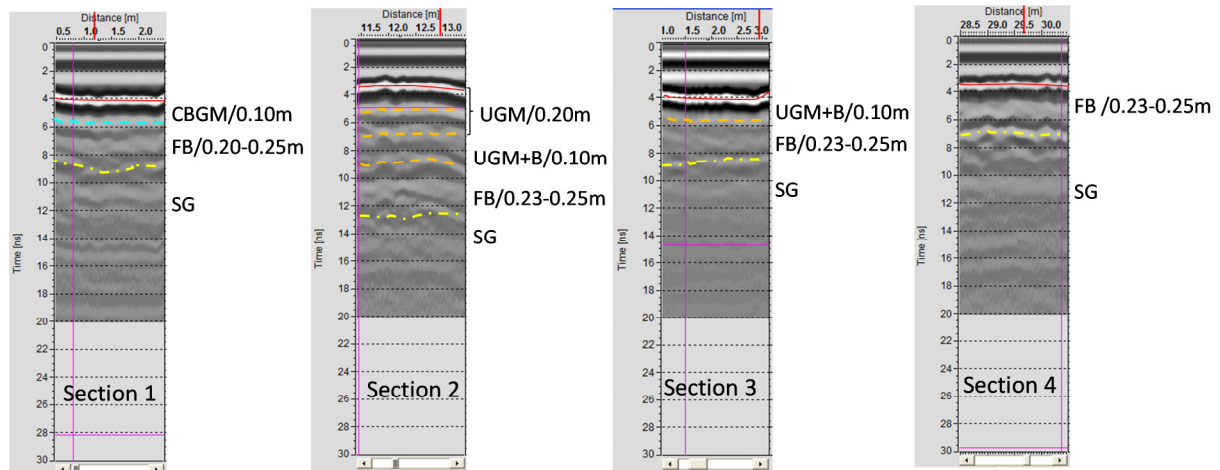
Figure 6: Tests with GPR on experimental sections.

After the construction of reinforcement layers, GPR tests were performed on the top of the experimental sections, for layer thickness measurement purpose. Figure 6 presents some of the results obtained in each section after GPR interpretation. It can be observed that the interfaces between the reinforcement layers and the existing ballast are generally visible. Also, it is possible to detect in Section 2, interfaces between the UGM layers given the fact they were placed and compacted in three different layers of 0.10m thick each. The results obtained with GPR confirmed the design values for thicknesses. These results were used during the back-calculation of FWD load tests, as presented in part 4 of this paper.

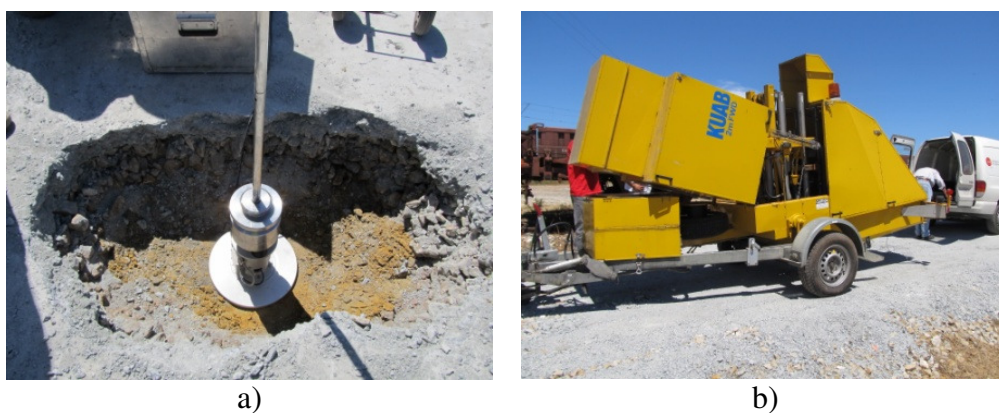
Figure 7: Load test equipment: a) LFD on the subgrade; b) FWD on the top of the reinforcement layer.

To measure the deformation modulus on top of the foundation, after laying and compaction of reinforcement layers, test pits were done, and loading tests were performed within, using a Light Falling Weight Deflectometer (LFD), as shown in Fig. 7a. This equipment was used as it was not technically possible to use the FWD, due the depth of the surface to be tested. The deformation modulus values obtained on the top of the foundation using a 0.30 m diameter plate, applying a vertical pressure of 200 kPa, were about 70-80 MPa. It should be noted that these results correspond to tests performed during dry season. Given the geotechnical characteristics of the foundation soils, deformation values may decrease with an increase in water content.

After construction, FWD tests were performed on the reinforcement layers (Fig. 7b), applying a vertical pressure of 400 kPa on a 0.30 m diameter plate. Deflections were measured using a set of seven geophones (the first was located at the centre of the load plate and the others at 0.30 m, 0.45 m, 0.60 m, 0.90 m, 1.20 m and 1.80 m). In Section 4, another test was performed on the top of the ballast using only the geophone located at the centre of the load plate. On the top of these layers more FWD tests were carried out two months after construction (September 2011), aiming at assessing whether the deformation modulus values changed over time, particularly due to the variation of the materials water content and change in stiffness of the cement bound aggregate mixture (in Section 1).

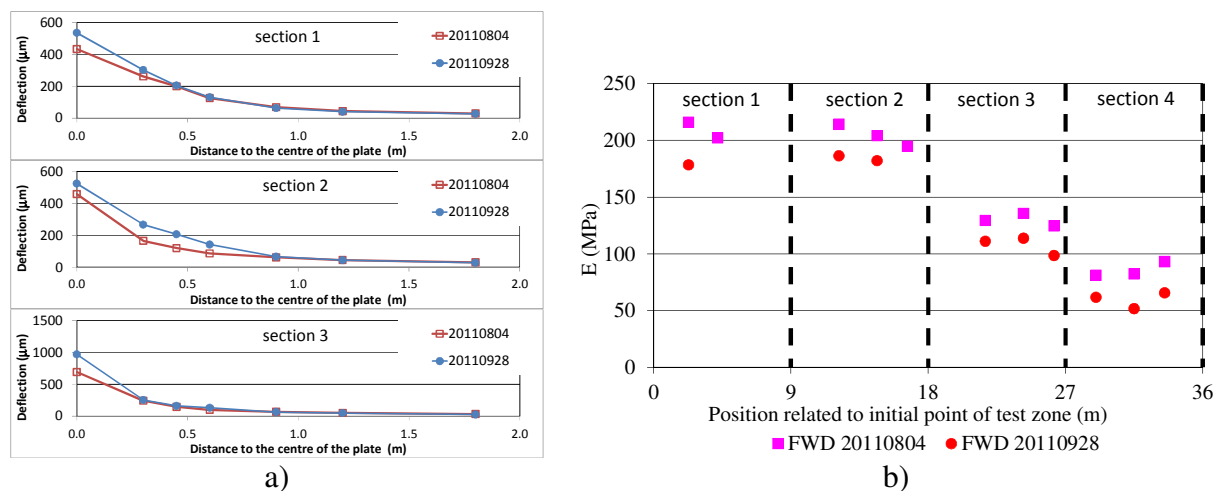
Figure 8: Results of the tests on top of the structures: a) deflections; b) resilient modulus.

The measured deflections during the two series of tests are presented in Fig. 8a. It is possible to conclude that there are some differences, being higher the deflections measured in September, particularly under the load plate and at some geophones in Section 2.

The deformation modulus was calculated according to equation (1) considering only the deflection measured at the centre of the load plate. The results obtained (Fig. 8b) lead to the conclusion that: a) in Section 1 and Section 2 deformation modulus values were about 200 MPa. The values of the load tests obtained in September 2011 (20110928) were 15% to 20% lower compared to those obtained in August (20110804); b) in Section 3, the deformation modulus values measured in the August were about 130 MPa, and the measured values in September were about 15% lower; c) in Section 4, where no new layers were placed, the deformation modulus values measured in August on the top of the old ballast layer were about 80 MPa, and decreased about 30% in September measurements; it should be noted that, as presented earlier, before removing the track and before compacting the old ballast layer at Section 4, the values of deformation modulus ranged from 50 MPa to 75 MPa.

The lower values of deformation modulus obtained in September may be due to higher water content of materials (which was not possible to measure), either in the aggregates or in the foundation soils, since rainfall occurred between the two series of tests. Taking into account the results, it is possible to conclude that the structural solutions built in Sections 1 and 2 led to the deformation modulus values higher than 120 MPa, as was established. However, if the tests had been performed after the rainy season, with higher water content values of materials, the deformation modulus values could have been even lower. Although the deformation moduli values of Sections 1 and 2 are similar, Section 1 has the advantage of having a thickness of 0.10 m, comparing with the 0.30 m of Section 2 solution; this can be significant in the situations where there are geometrical constraints. The solution of Section 3 hardly achieved the minimum value established for the deformation modulus (particularly the values obtained in September tests), having however the advantage of being cheaper, easier and quicker to build.

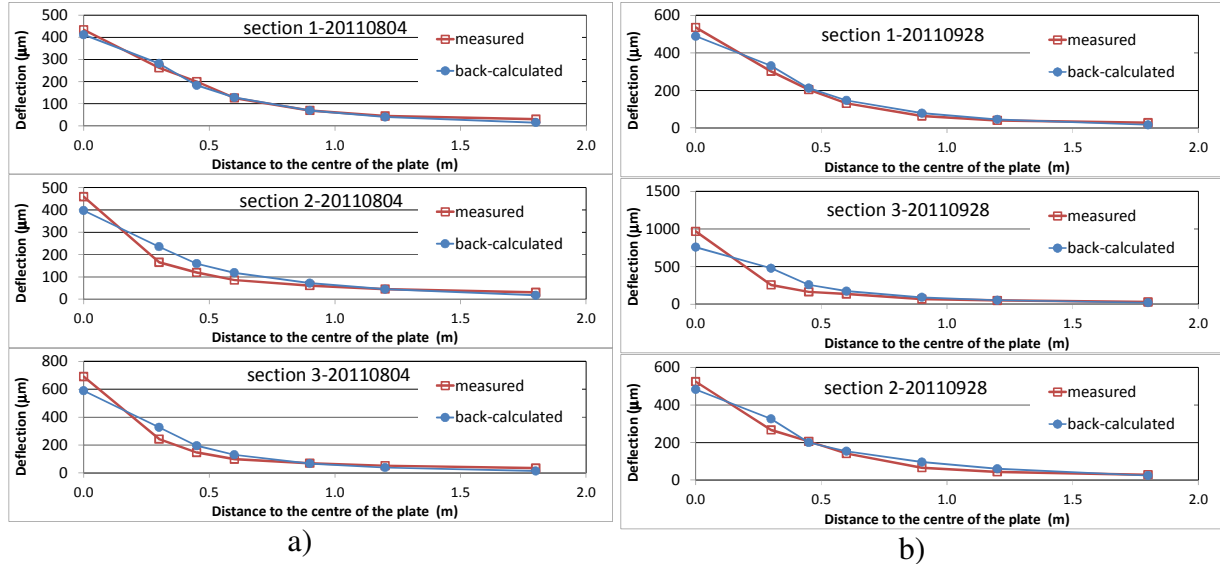
Figure 9: Measured and back-calculated deflections: a) first tests, August; b) second tests, September.

The back-calculation study was developed for the representative point of each section (near the middle point of the stretch), using the BISAR software. In general, it was possible to achieve a good fit to the measured values (Fig. 9).
