Case histories using foamglass for roads to reduce settlement and stability problems

M. Hagen, J. Vaslestad
Norwegian Public Roads Administration

KEY WORDS: Foamglass, repair of unstable steep slopes, lightweight embankments

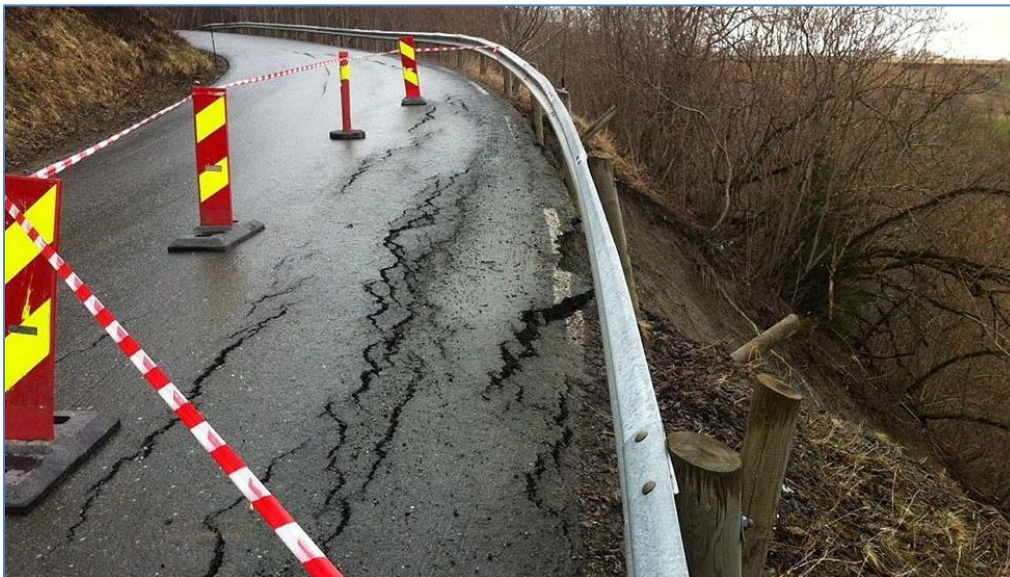
Figure 1: This picture is from Fv 734 (Varmbuvegen) in Melhus in Sør-Trøndelag ^[13]. It is a typical example of problems with instability in steep slopes and where it is large expectations regarding the method described in this paper. In Norway there is a large number of steep slopes with similar problems.

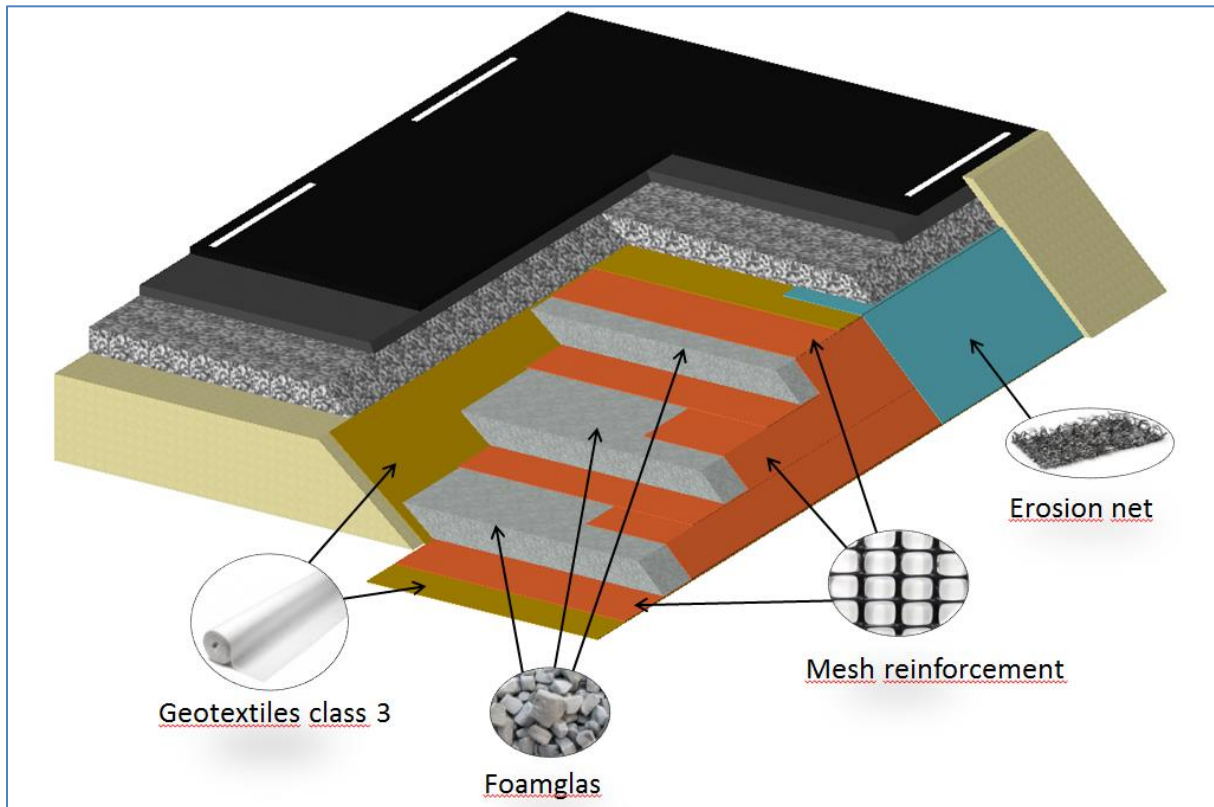
Figure 3: Illustration shows how to build a steep slope with foamglas. The inner half of the road is not renewed, which makes it possible for cars to pass during construction phase ^[8].

The here mentioned building method is based on the process for stabilizing steep slopes on highway 120 in Østfold. Foamglas is used in 3 layers, whereas each layer is separated and anchored with mesh reinforcement. It is the building technique with 3 layers of foamglas, combined with mesh reinforcement to stabilize the filling, that differs this method from others and more established building methods. The inner half driving lane remains untouched during the construction period, allowing traffic to be maintained. On the construction sites in Østfold the traffic has been regulated with traffic lights ^[4].

At first the existing masses is removed from the middle of the road and towards the facing slope side. The slope angel is about 40 degrees on figure 3, and also the calculations regarding density take in to consideration of an angel equal to 40 degrees. On the actual construction sites this angel was significantly higher (70 up to almost 90 degrees) ^[1]. It is at this time unclear whether a steep angel can cause problems regarding frost heave, because of an abrupt transition between a frostsafes and not frostsafes road ^[5]. Therotically the inner road can rise during frost heave if the slope angel is significantly higher than 40 degrees. The here mentioned method is so new that we do not know for certain whether this can actually become a problem.

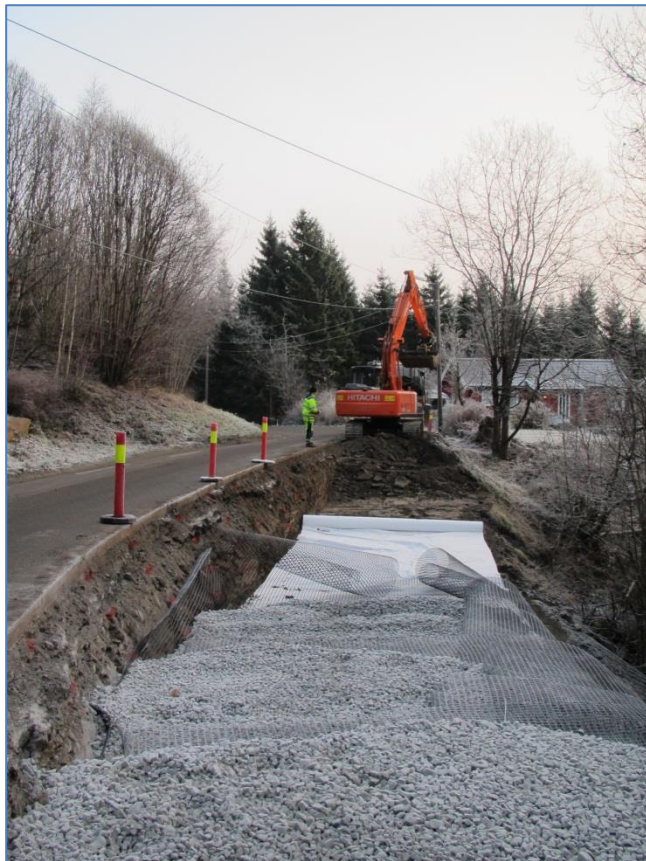
Figure 4: Foamglass is delivered. levert. Notice the geotextiles at the lower background in the picture. This slope is located on highway 120 north of Tomter, Østfold ^[14].

Regardless a larger amount of the masses is changed with a higher slope angel, and further reduces the weight of the filling ^[1]. The actual weight reduction on the construction sites is therefore probably higher than the calculated 47 %, according to the density attachment (not included in this paper). When the masses have been removed, geotextiles class 3 is added at the bottom of the excavated area. Another benefit concerning an operative inner driving lane: Truck with side tip simplifies the delivery of foam glass.

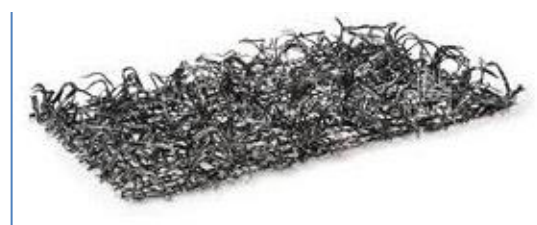
Figure 5: Erosion net Naue Secumat 20 mm ^[15].

Geotextiles is added at the top of the foamglass, and is then covered with a 30 cm thick layer of crushed rock, as part of the upper superstructure. The geotextiles prevents the stone materials from mixing with foamglass. Before the layer of crushed rock is added, erosion net is added 1 m within the slope edge. The weight of the superstructure anchors the erosion net well. The erosion net is added above the geotextiles.

The erosion net that was used was Naue Secumat 20 mm ^[4] (figure 5). The layer of crushed rock was compressed by a 500 kg vibroplate. Above was added a 20 cm thick layer of asphalt, which eventually was rolled.

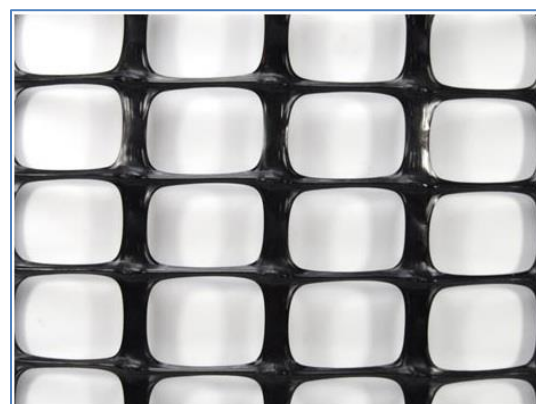
Figure 6: Armeringsnett av typen Tenax Geogrid LBO 330 ^[16].

A 15 ton excavator with tracks drove over the foamglass once to allocate it. The excavator has a ground pressure well below maximum at 50 kN/m^2 . Thereafter each layer of foamglass were compressed by a 60-70 kg vibroplate. The total thickness of the three layers of foamglass is 1 meter after compression. Each layer has the same thickness. For each layer mesh reinforcement is wrapped around the foamglass with an overlap of 1 meter. Then a new layer of mesh reinforcement is added from the inner edge of the excavated area, to the edge and around the foamglas with 1 m overlap, exactly like the layer beneath. The mesh reinforcement that was used is Tenax Geogrid LBO 330 ^[4] (figure 6).

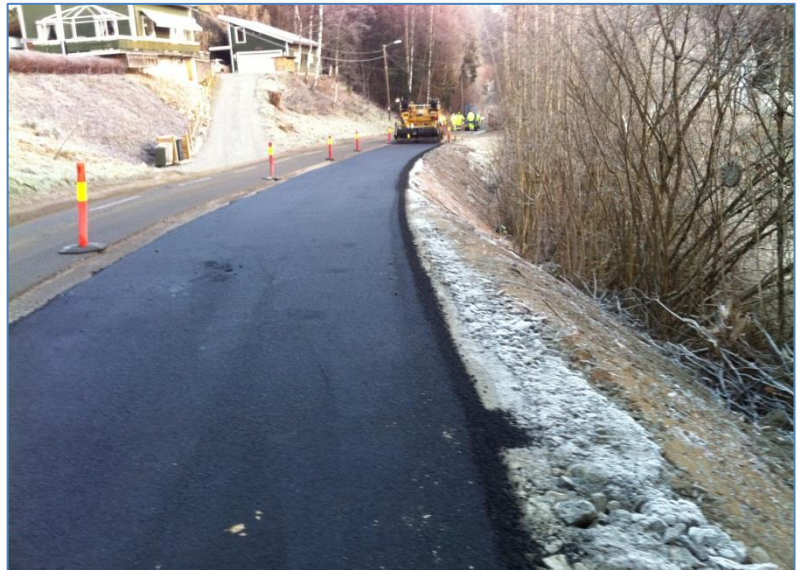
Figure 7: New layer of asphalt. Notice the cogging that is cutted into the untouched part of the road ^[9].

After the superstructure was completed, a cogging (figure 7 7) was cutted into the asphalt approximately 0.5 m into the untouched part of the road to create a joint that is not thorough. This also prevents water from entering ^[4].

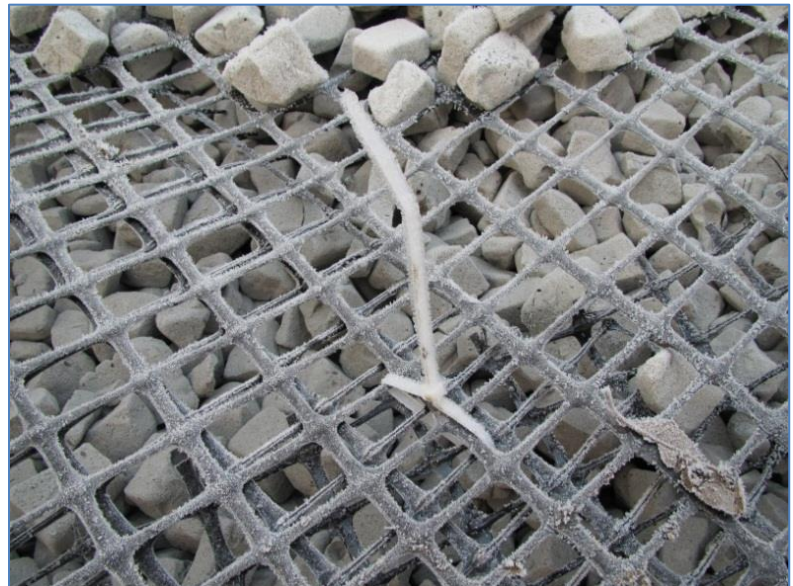
Figure 8: Geotextiles are joined with strips ^[14].

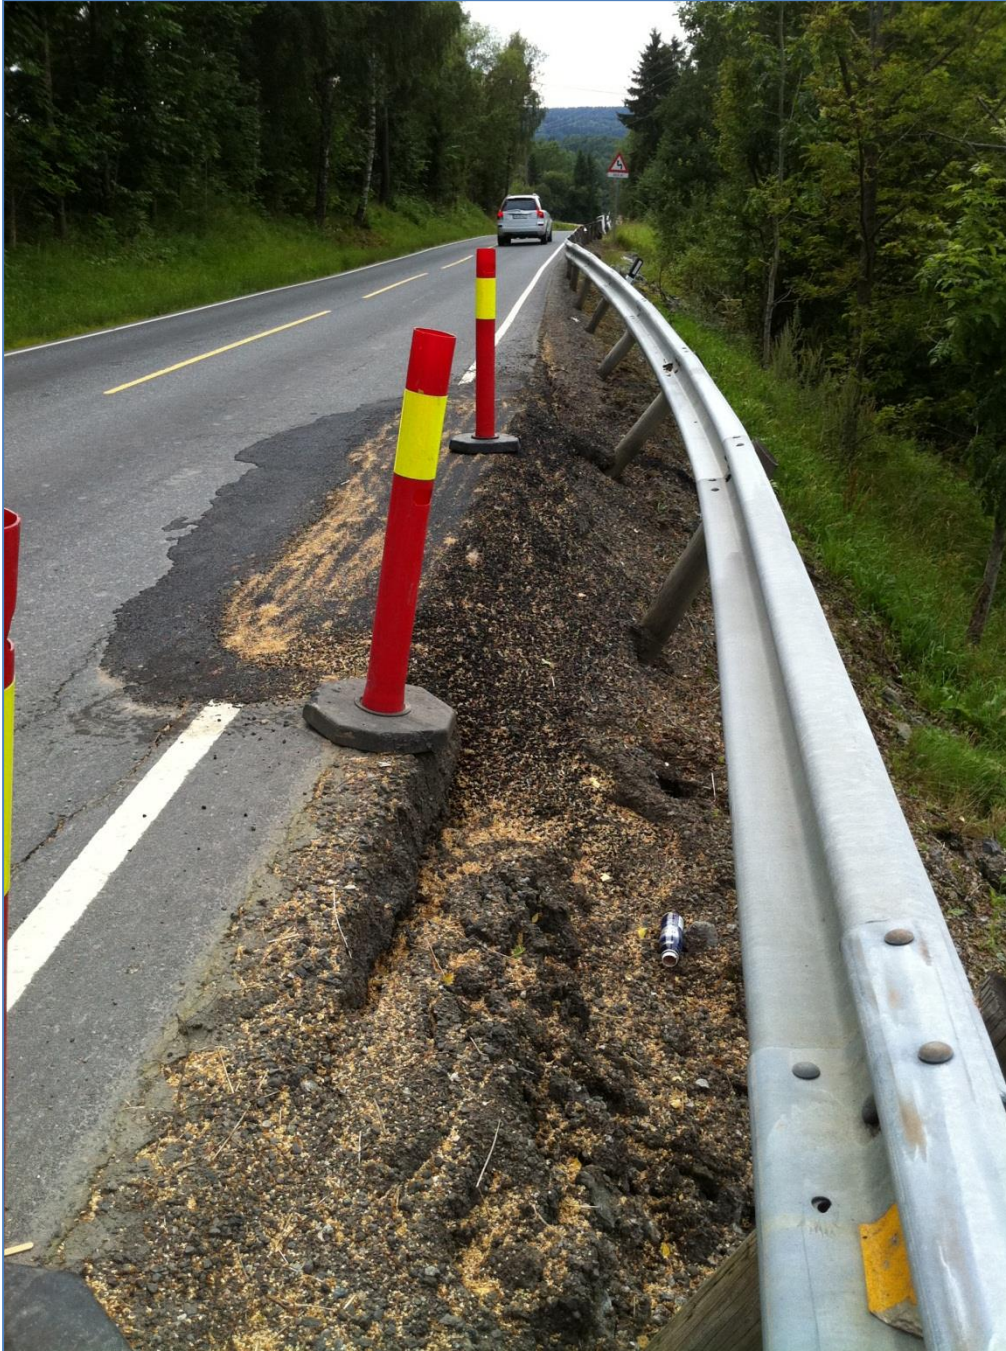
Figure 9: Picture from Fv 115 south for Mønster bridge before the repairations were started in fall 2011^[9].

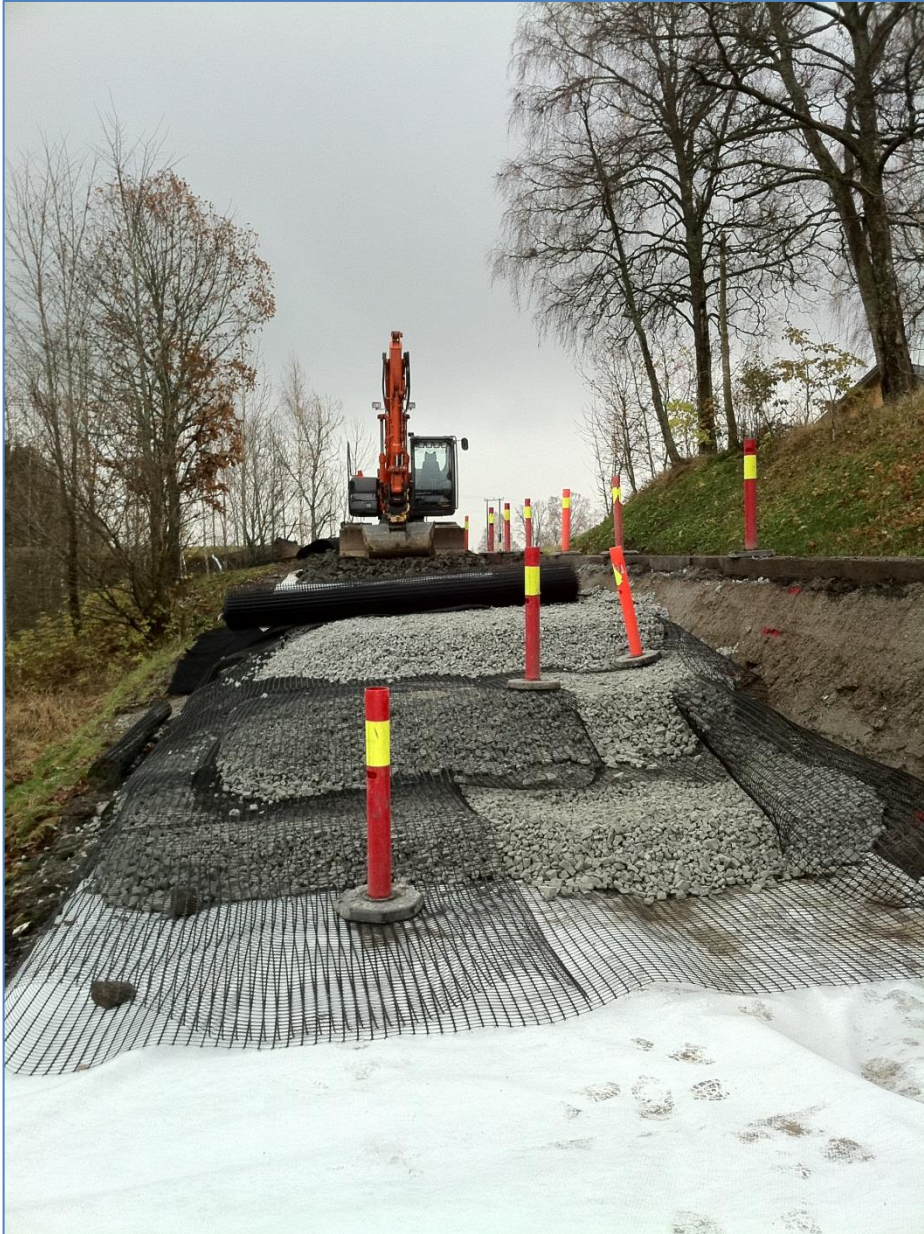
Figure 10: Picture from Fv115 south for Mønster bridge (Østfold, Norway) during constructuin phase. Observe the three layers with foamglass which is separated by reinforcing mesh ^[9].

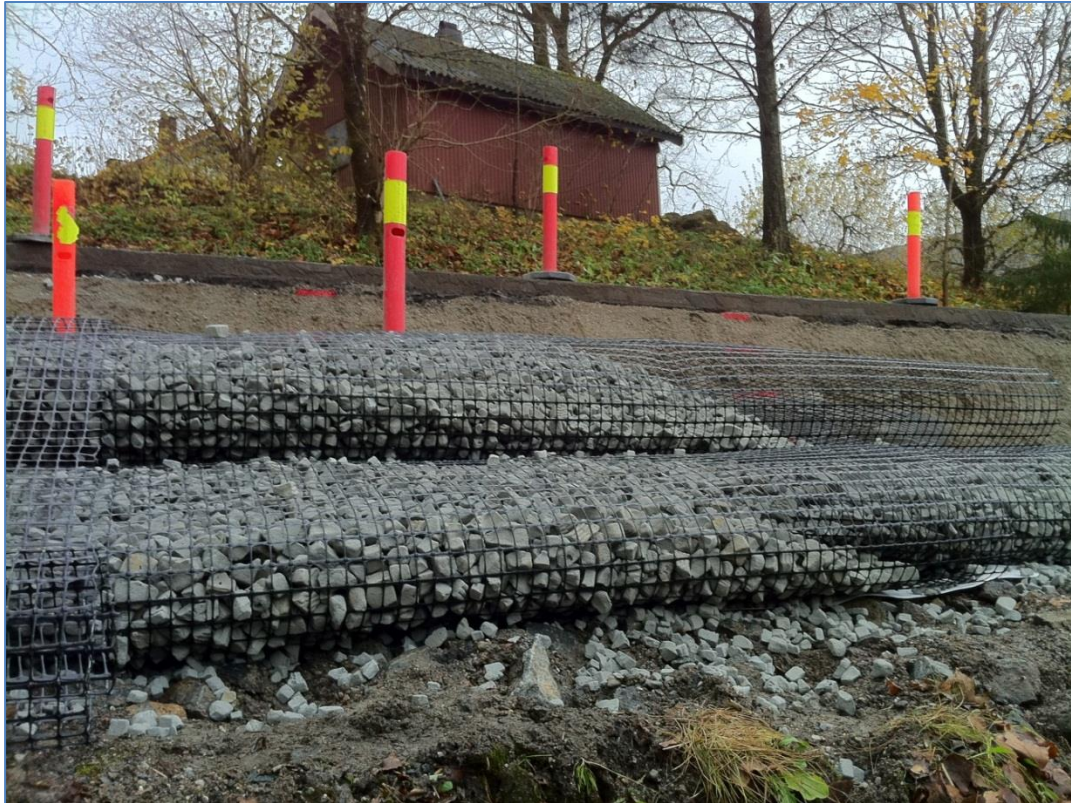
Figure 11: Mesh reinforcement around the foamglass ^[9].

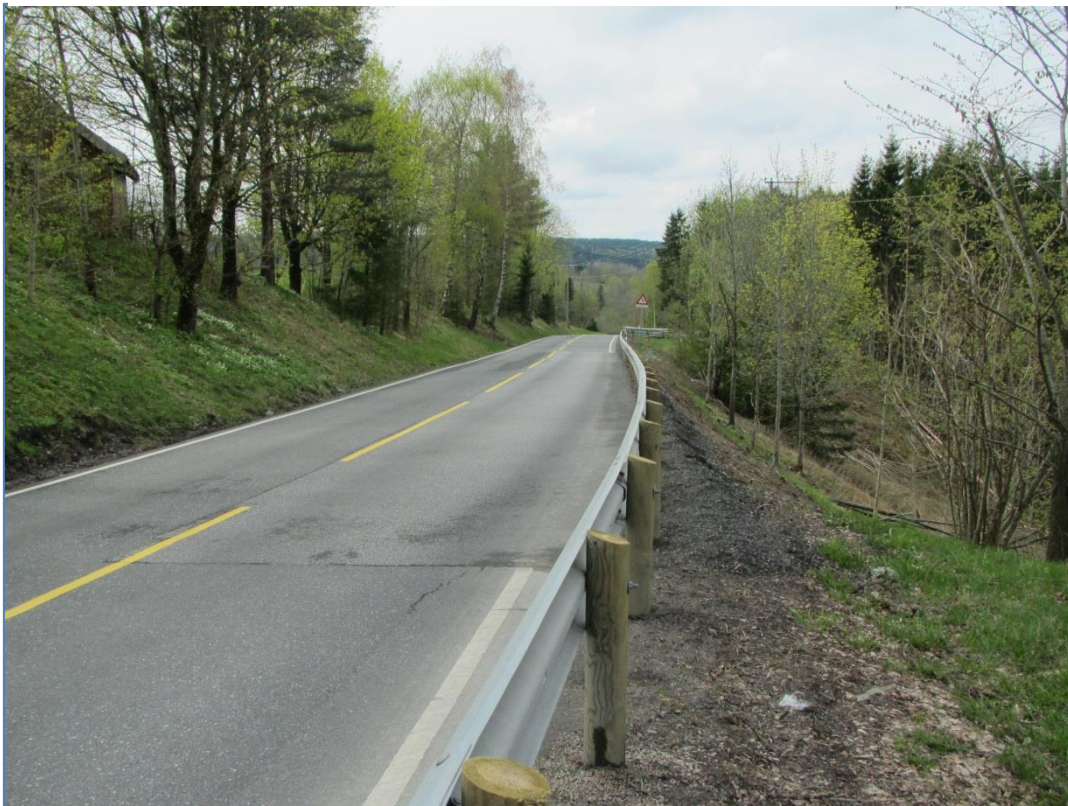
Figure 12: Same place as figure 2. Picture is taken 9th may 2012 when the projectgroup was on inspection. 6 months after the first inspection there is no signs of deformation or settlements of the area that was repaired in fall 2011 ^[14].
