Roller-compacted Concrete Pavements in Norway 20 Years Experience

J.E. Dahlhaug, T. Haugødegård, L. Jenssen, I. Markey, K. Melby, P. Ø. Ohnstad,
O. L. Strømme, O. Sæveraas
Norwegian Public Roads Administration (NPRÅ), Norway

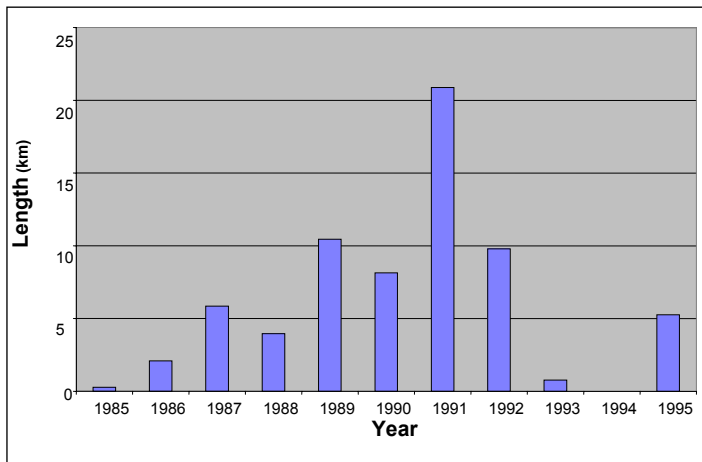
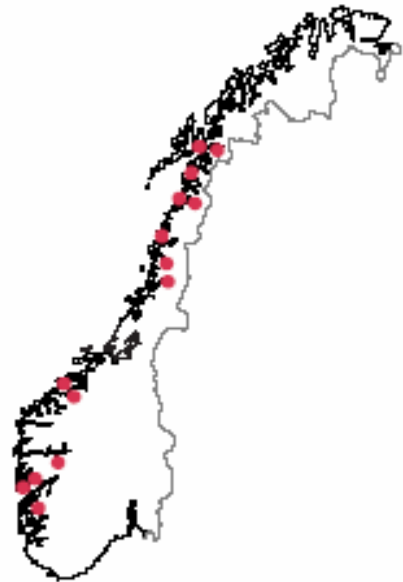
Figure 1: Constructed roller-compacted concrete pavement by year and geographic location.

Several trials with roller-compacted concrete pavements were performed in Norway at the beginning of the 1980s. The concrete was placed with a normal road scraper/planer, but sufficient pavement quality was not obtained. In 1985 a new trial was performed in Nordland County in the northern part of Norway. This time an asphalt paver was used in addition to applied cement-stabilised subbase technology. During the period 1985 till 1995 a total of 68 km (centre line) of roller-compacted concrete pavement was constructed on national primary roads in four coastal counties.

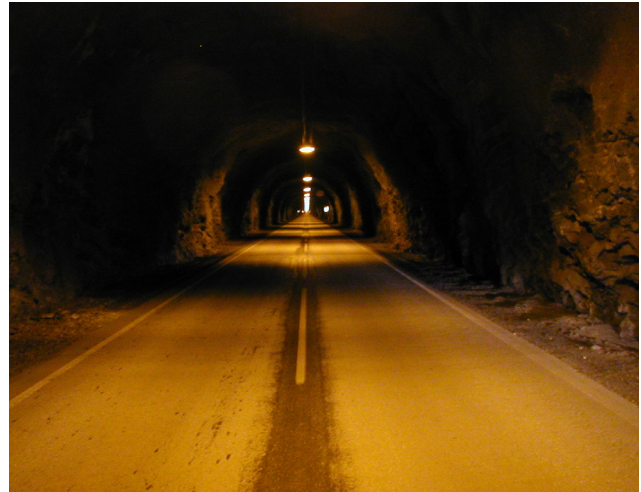
Figure 2: The picture shows a roller-compacted concrete pavement in Steigen Tunnel.

The tunnel is straight and built for small traffic volumes. Production of the pavement went well. However, each lane was paved separately resulting in a longitudinal joint of low quality that had to be repaired shortly after completion. Due to small temperature variations and low traffic loading, the pavement is in excellent condition after 15 years of service and a lifetime of 100 years is possible.

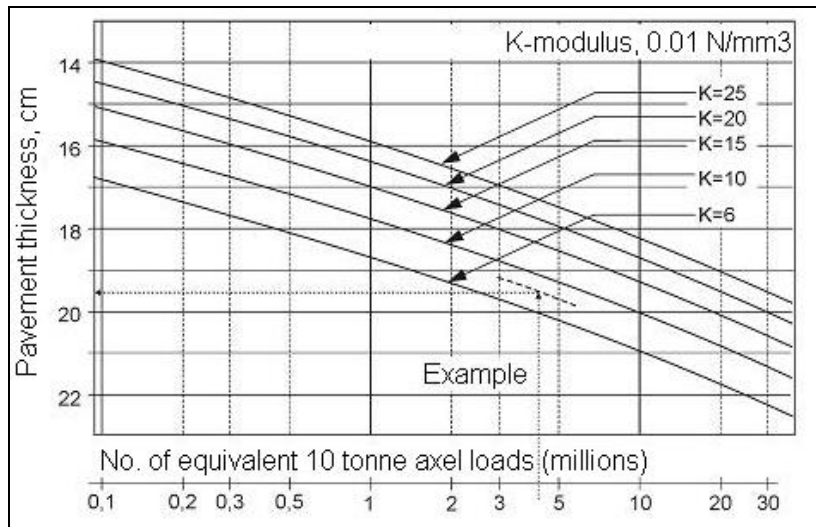
Norwegian roads are designed for 10 tonne axle load and a 900 kPa tyre pressure. Roller-compacted concrete pavements are designed in a similar fashion to other un-reinforced concrete pavements where support from the underlying material is taken into consideration. A diagram is produced by NPRA, mostly from practical experience, where parameters are

corrected for AADT and the support K-modulus. The basis for the diagram is a five meter long plate and compressive strength corresponding to a C35/45 concrete (EN206-1).

Figure 3: Pavement thickness from corrected AADT and K-modulus (1).

The K-modulus of the substrate or underlying support can be obtained from a plate loading test (AASHTO T222-78). Accepted or reference values can also be used, they are more common for practical purposes. The substrate is divided in six bearing capacity groups in the Norwegian design system. Each group is assigned a characteristic K modulus value. This value is then corrected for the actual pavement thickness and the load distribution coefficient of the subbase (the load distribution coefficient is part of the Norwegian index method and gives load distribution relative to a gravel subbase, which has a coefficient of one).

For concrete compressive strengths higher than C35/45, the pavement thickness can be reduced using accepted correction factors. As studded tyres are common in winter, the design of the pavement must also take this into consideration. High compressive strength concrete is more resistant to rutting by studded tyres.

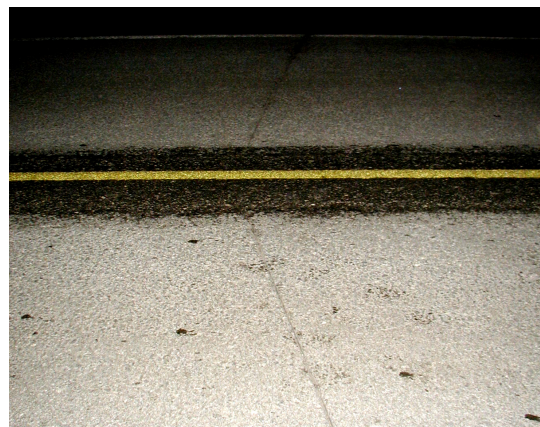
Figure 4: Inclined joints after approximately 15 years service. Longitudinal centre joint was repaired after uncontrolled cracking.

Several trials were performed with different joint spacings. Uncontrolled cracking was observed for spacings up to 25 m. For 12 m joint spacing in a tunnel, large joint deformations were observed when heavy load vehicles passed. The problem was greatly reduced by cutting new joints at 6 m spacing. In the Norwegian Guideline, joint spacing is specified as 6-8 m. In some tunnels, inclined joints are cut in the concrete as this reduces noise and loading on the edge of the joint.

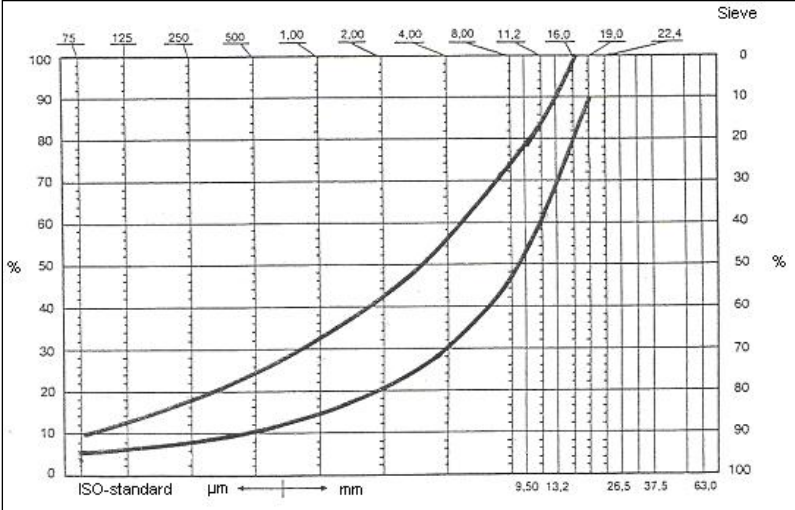
Figure 5: Recommended aggregate grading limits for roller-compacted concrete (1).

improve the compaction. For the final projects the ratio was 3:1 natural/crushed stone. In addition, aggregate grading close to the recommended upper limit for roller-compacted concrete was used in the final projects in order to improve the surface finish. At the same time, maximum aggregate size was reduced to 16 mm in order to reduce the risk of separation.

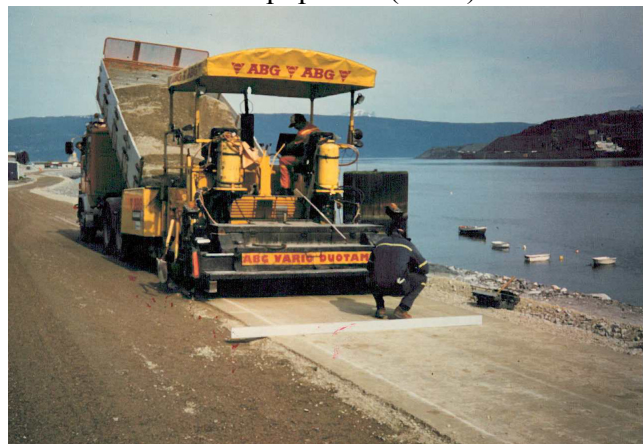
Figure 6: Casting roller-compacted concrete on one of the first projects.

The choice of road paver is critical for the quality of the pavement as homogenous compaction of the fresh concrete must be performed as soon as it is laid. For the first projects a relatively light paver was employed, but from 1986 heavier equipment (ABG) with double tamper knives and vibration plate was used. From 1991, a paver with a special screed (VØGELE) for high speed compaction was used. The ABG paver had hydraulically powered variable screed width and the possibility of laying widths up to 4.5 m and 8 m, while the VØGELE paver had constant screed width intervals of 0.5 and 1.0 m.

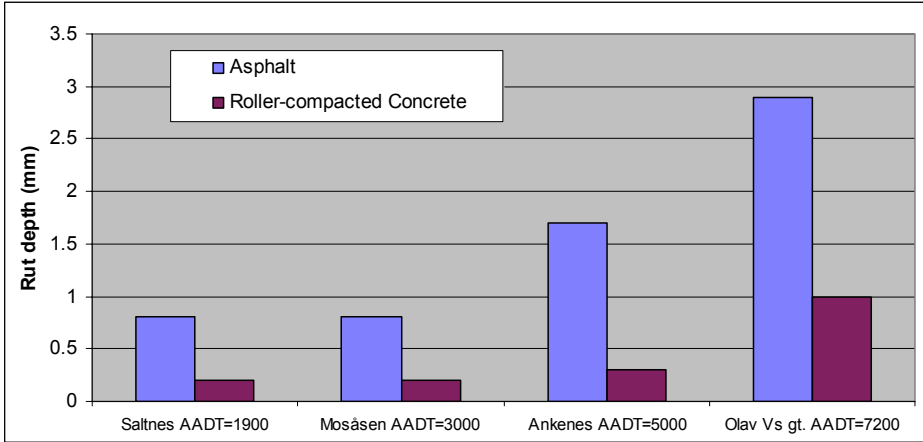
Figure 7: Observed rutting per year (mm) for stretches of road with asphalt and roller-compacted concrete pavements.

cause for surface replacement, especially for asphalt wearing surfaces. This results in re-asphalting every 3–6 years with correspondingly relatively high costs.

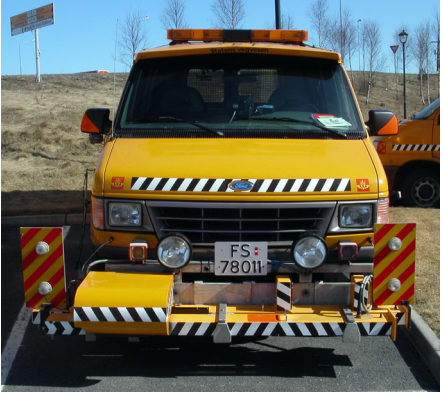
Figure 8: Vehicle "ALFRED" used for measurement of road surface unevenness and texture.

The condition of concrete pavements in tunnels is recorded every year by the ALFRED measurement vehicle in accordance with standard procedures. Rut depth and IRI (International Roughness Index) are calculated for 20 m sections and are used in the PMS (Pavement Management System) for detailed planning of maintenance activities for rolling six-year periods. Over 95% of the national road network is measured in this way every year. The results are stored in NPRA's Road Data Bank.

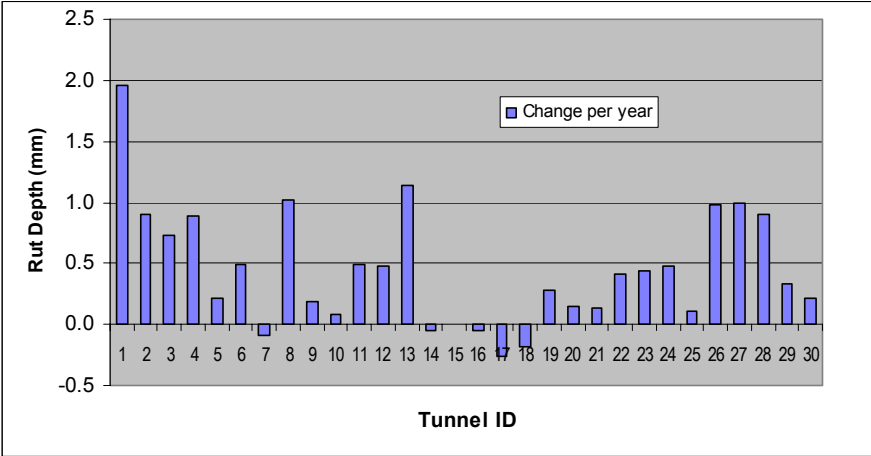
Figure 9: Annual development (change/year) of rut depth for 30 tunnels with roller-compacted concrete pavements. Small rut depths and scatter in the measurements results in certain tunnels being attributed with negative rut depth.

Measurements performed on roller-compacted concrete pavements show very small annual increases in rut depth and IRI. Based on measurements performed the last 10 years, the annual average increase in rut depth for all roller-compacted concrete pavements is 0.3 mm/year. Where the AADT is close to 10000 vehicles, the increase in rut depth is 1–2 mm/year.

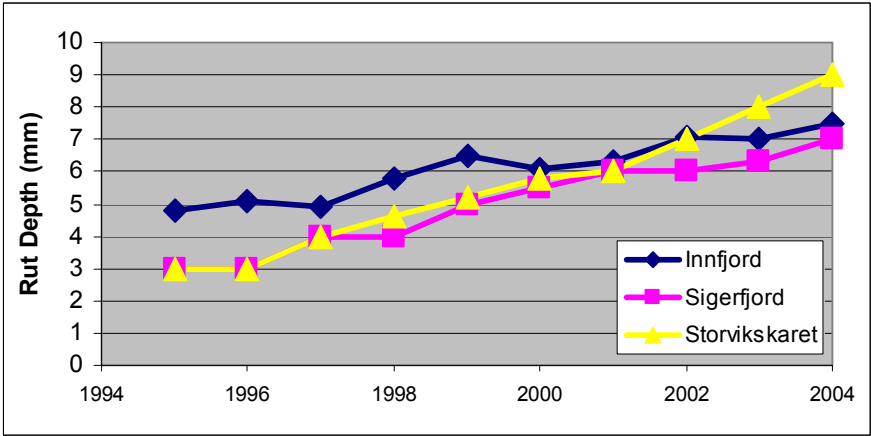
Figure 10: Development of average rut depth with time for three tunnels in the period 1995–2004.

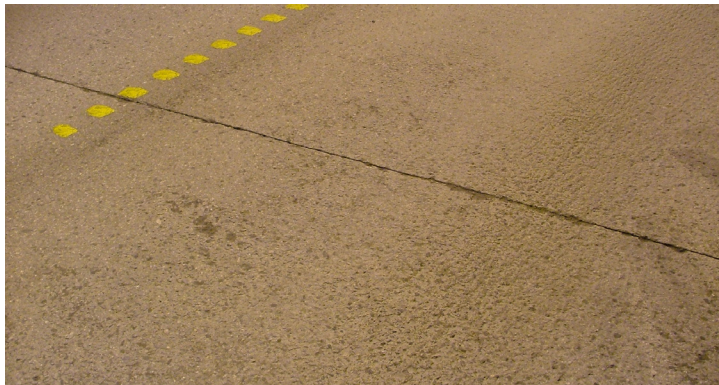
Figure 11: Example of a joint.

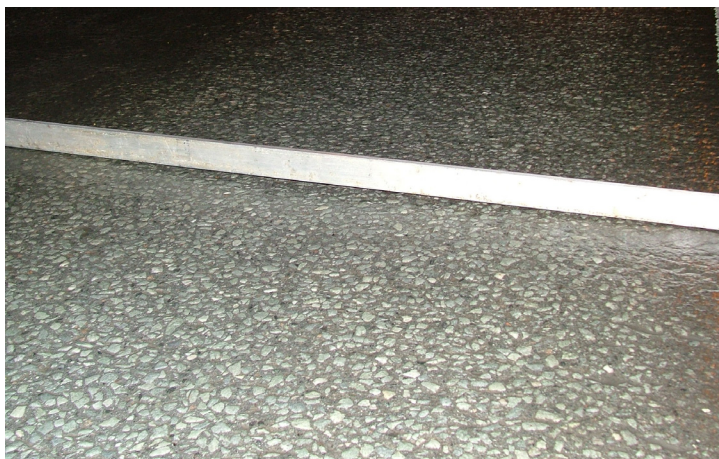
Rubber coated rollers were used during paving to increase the proportion of aggregate in the surface layer, as this gives a better surface resistance against studded tyres.

Figure 12: Example of good distribution of aggregates on the surface.
