## Sulfate Attack on Stabilized and Recycled Materials in Pavements

**ABSTRACT:** There have been several instances of sulfate attack on portland-cement- and lime-stabilized materials and on recycled portland-cement concrete used in pavements at US Air Force (USAF) airfields. While the chemical reactions are similar to those found in conventional sulfate attack on portland-cement concrete, the nature of the attack in a pavement setting makes conventional methods for protecting portland-cement concrete from sulfate attack ineffective for these stabilized and recycled materials. This paper will review the nature of the failures encountered on these USAF facilities. These examples show that even use of Type V sulfate-resistant cements proved inadequate to prevent attack. The paper will conclude with a discussion of our current shortfalls in knowledge and guidance in this area.

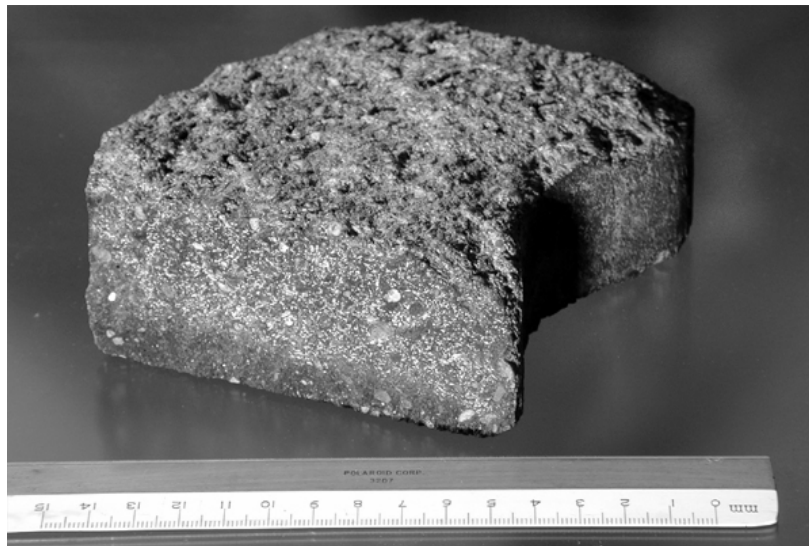
Figure 1 shows a concrete paving block manufactured with ordinary Type I portland cement that is undergoing sulfate attack. The block is dense, high strength ( $>1.2$  MPa ( $>8,000$  psi)), and the visible damage occurred in less than 6 months. The block in the figure is turned on its top with the bottom up where approximately 12 mm (1/2 in.) of material is gone and fragments can be popped from the remaining material with moderate pressure. The white formation visible is the ettringite, and it has formed through much of the block. The block had been laid in a bed of industrial cinders that contained the sulfates and progressive wetting and drying led to rapid attack on the bottom of the block with progressive migration upwards through the block. This attack destroys the concrete matrix resulting in a progressive almost rotting away of the concrete starting from the source of the attack. Strength alone is no protection against this chemical attack. Sulfate-resistant cements should have been used.

Figure 1: Concrete paving block undergoing sulfate attack.

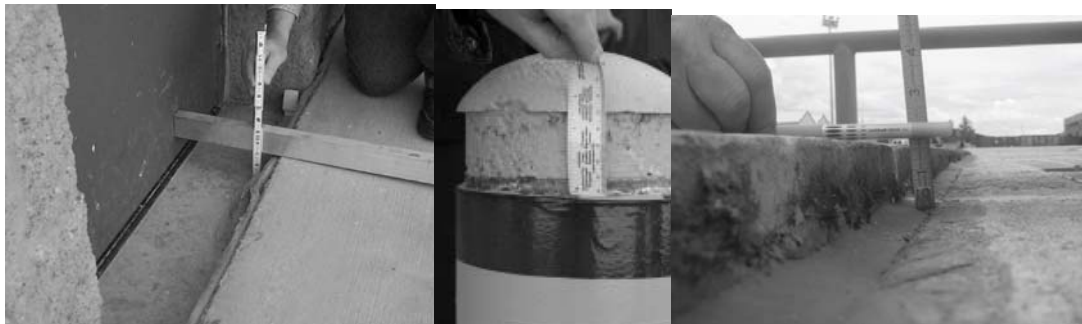
Shortly after construction, heaving began, appearing initially in a few areas and then spreading in an erratic pattern. Inspections in March and July of 2000, April of 2002, January and August 2004, and February 2005 have found that the heaving is becoming progressively worse and more widespread with time. The magnitude and severity of heaving varies and several examples are shown in Figure 2. Upheaval is occurring in a variety of structures founded on the recycled concrete fill (rigid pavements, flexible pavements, foundation slabs, and sidewalks). Initial small elevation changes at the fuel trench have grown so that they now are causing cuts on tires as aircraft traverse the area. These surfaces were ground flush in 2003 but are heaving again. Doors in the maintenance hangar are sticking, and in one case where upheaval exceeded 75 mm (3 in.), the door could not be opened until the area was reconstructed. The maintenance hangar floor which is a stiff, bidirectional ribbed-mat foundation is rippled in some areas. The situation obviously is causing the owner much distress. A complete report of the site and the investigation is being published (Rollings et al 2005).

Figure 2: Examples of heaving (from left to right): heaving at door adjacent to maintenance hangar, concrete extruded from a bollard by expansion in recycled concrete base, and heaving of pavement on recycled base adjacent to fuel trench founded on subgrade.

Samples removed from the recycled concrete base found abundant ettringite and thaumasite. Sulfate attack is clearly occurring and is the probable cause of the observed heaving. No evidence was found that the heaving came from expansive soils (which can mimic many of the observed symptoms) or alkali-silica reaction (which is common on the base). Clearly, sulfate attack on this supposedly sulfate-resistant concrete is occurring.

Several factors contribute to the sulfate attack on this nominally sulfate-resistant recycled concrete. When the concrete was crushed to use as a recycled base, it became much

more permeable to both water and sulfate salts in the local soil and groundwater. Consequently, the reduced alumina present in the Type V cement now had ready access to these critical contributors to sulfate attack. Dense impermeable concrete has always been considered as an important part of the protection against sulfate attack, and in a permeable crushed form, the recycled concrete is simply more vulnerable to attack than when it exists as conventional concrete. Under the paved surfaces, there is abundant moisture and sulfate available in the recycled base, and simply relying on Type V sulfate-resistant cement to combat sulfate attack is inadequate.

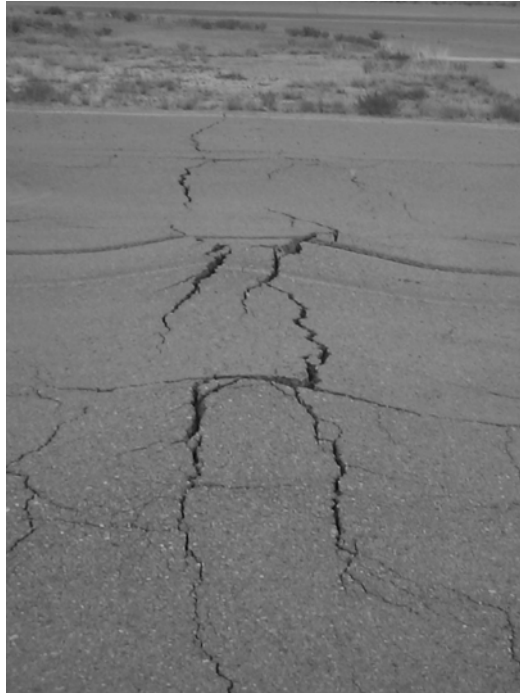
Portland-cement stabilization provides the same chemical ingredients as conventional portland-cement concrete to support formation of ettringite and sulfate attack. Use of Type V sulfate-resistant cement would appear to provide the same protection to cement-stabilized materials as it does conventional concrete. This proves untrue unfortunately. As with lime stabilization, portland-cement stabilization raises the system pH thereby freeing chemically active alumina from the soil minerals to participate in the undesired formation of ettringite. This negates the usefulness of the low-alumina Type V cement. Figure 3 shows an example of sulfate attack on a taxiway's stabilized base made with Type V sulfate resistant cement.

Figure 3: Heaving of a taxiway surface caused by sulfate attack on a cement-stabilized base made with Type V sulfate-resistant cement, Holloman AFB, New Mexico.
